WALKABILITY AUDIT REPORT PENN TOWNSHIP LANCASTER CO.

Reducing chronic disease among Lancaster County resident

WALK AUDIT BACKGROUND

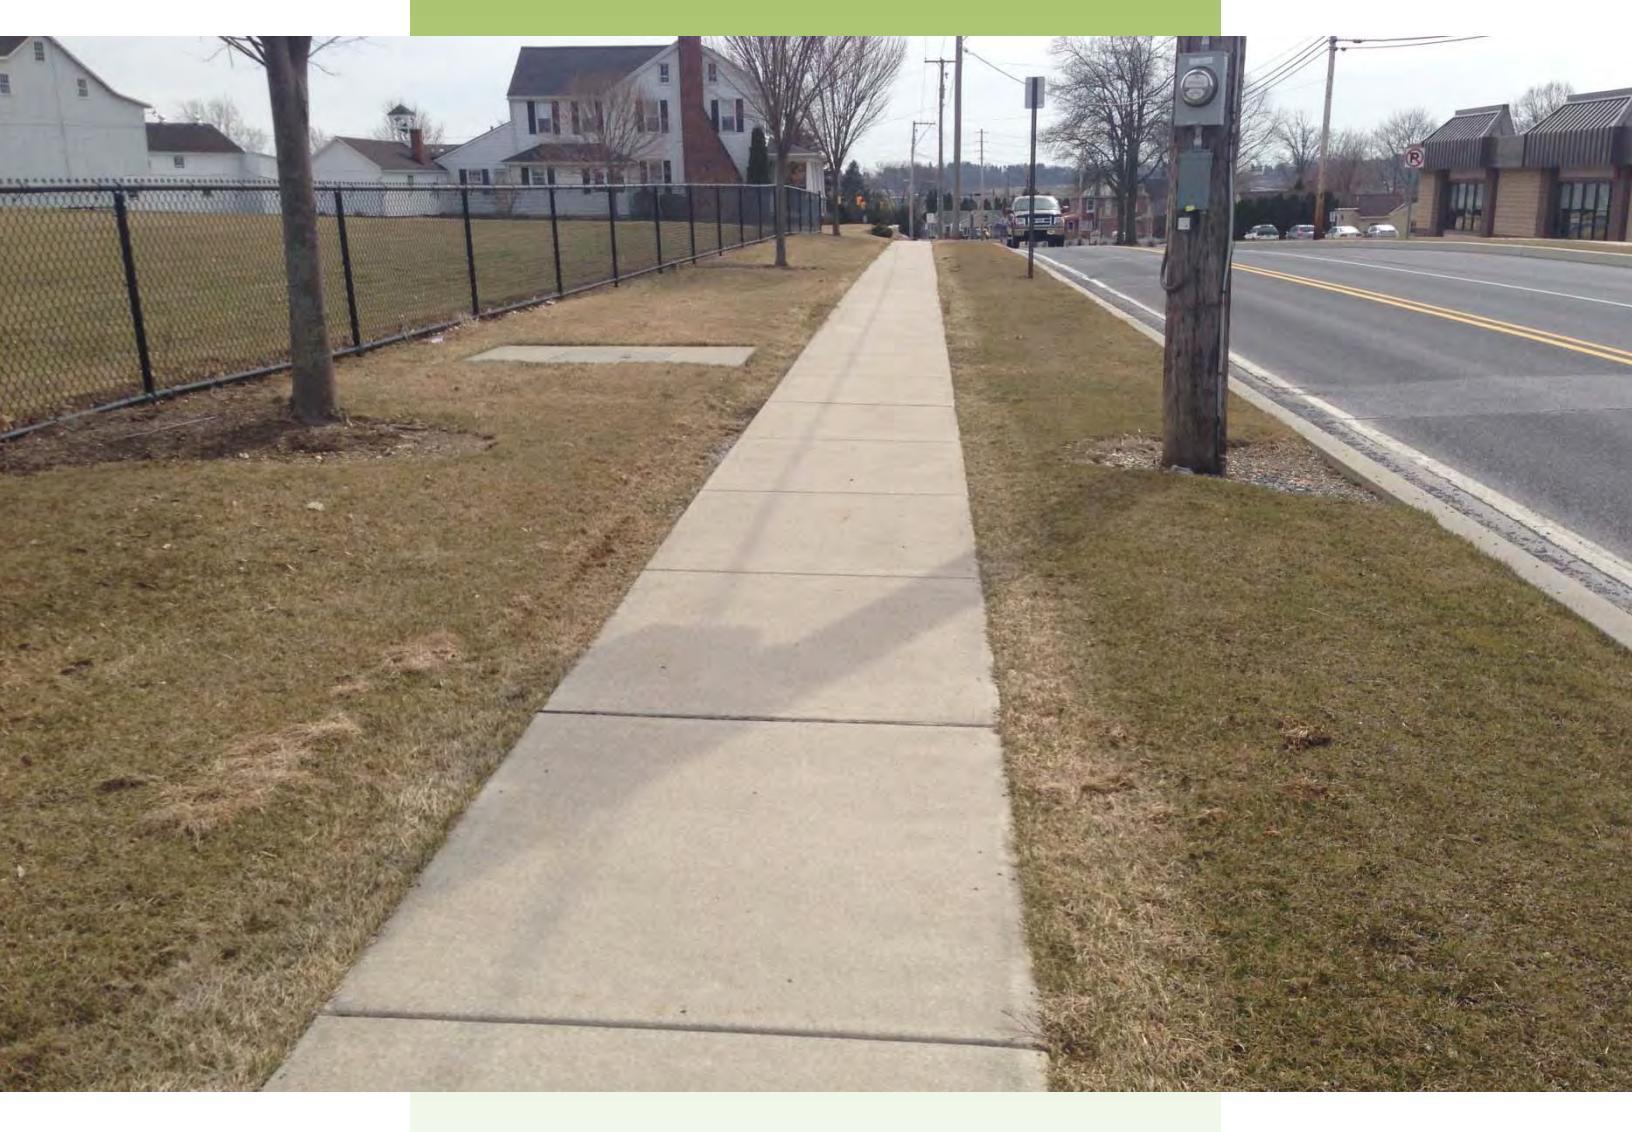
N. PENRYN CONDITIONS

Typical concrete sidewalk is present along the eastern side of the roadway.

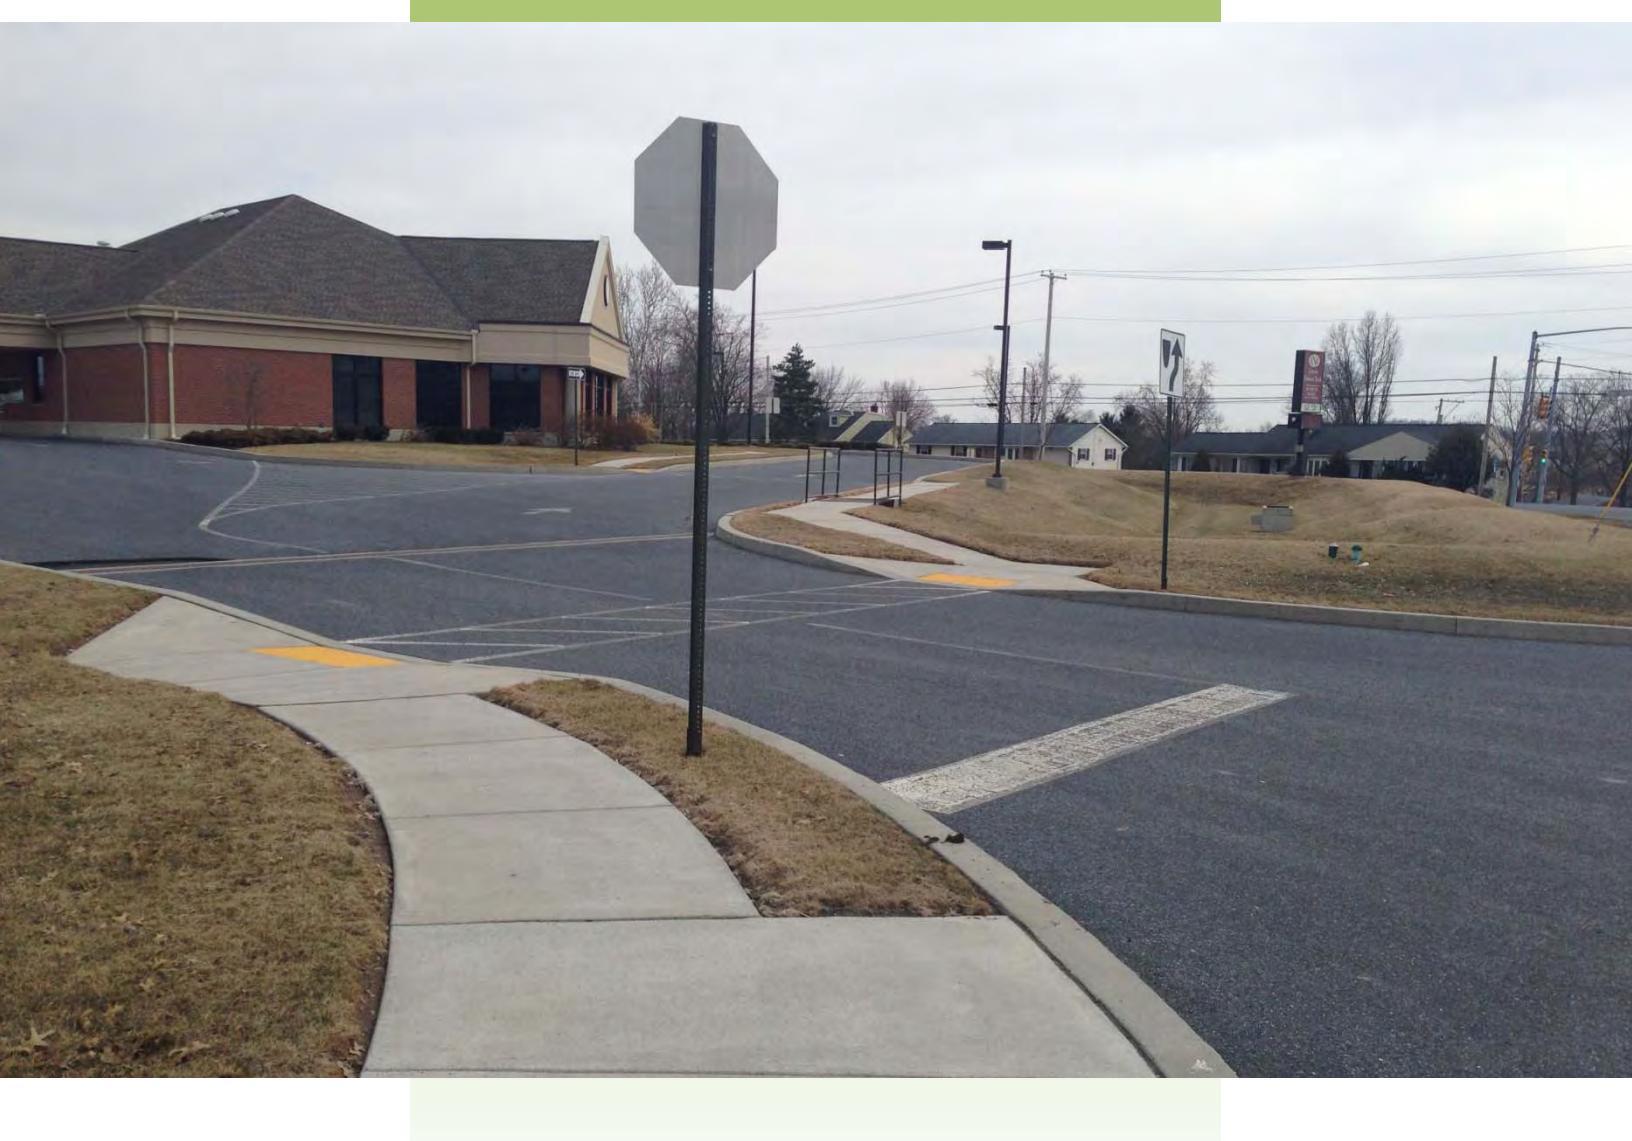
N. PENRYN CONDITIONS

Crosswalks and ADA ramps are provided across bank driveway. The location of the crosswalk behind the stop sign is not ideal as it represents a conflict between vehicular and pedestrian movements. No sidewalks are provided south of the bank driveway.

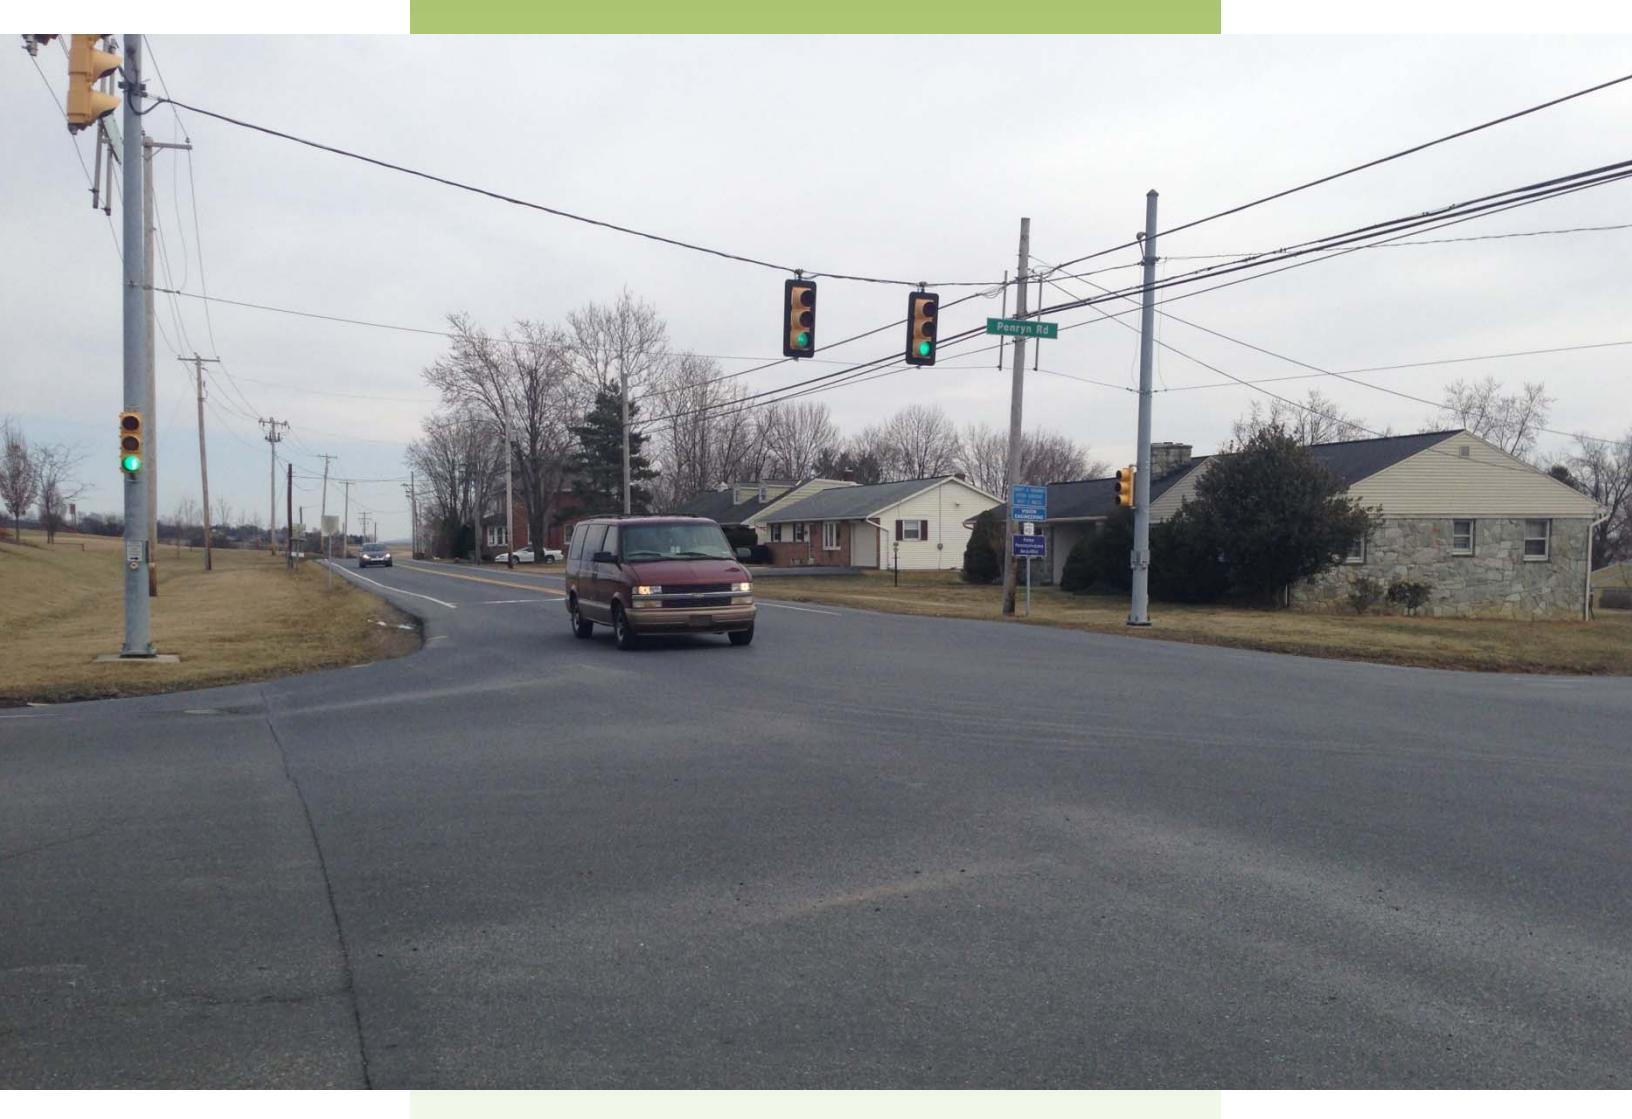
N. PENRYN CONDITIONS

Pedestrian push buttons are available the intersection of North Penryn and Doe Run Roads; however no crosswalks are provided.

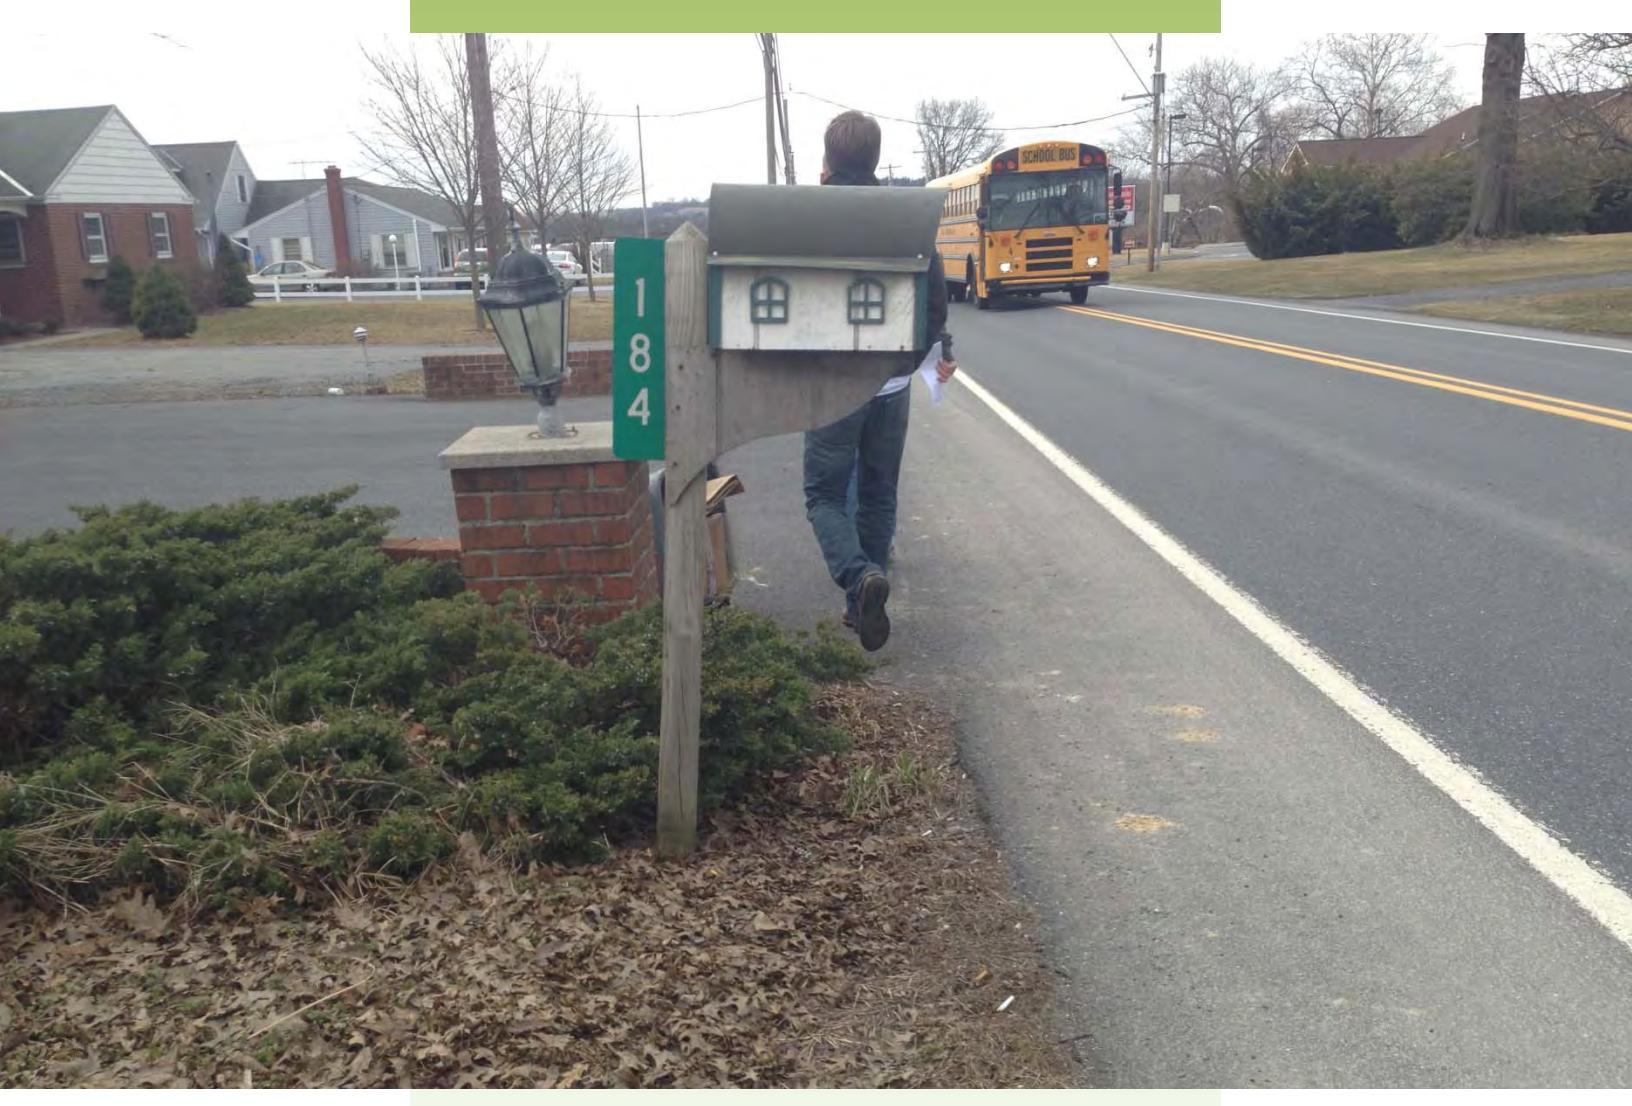
Many existing structures offer resistance to walkway opportunities, forcing pedestrians closer to traffic. Note the school bus crossing the double yellow center line into opposing traffic to give room for pedestrians.

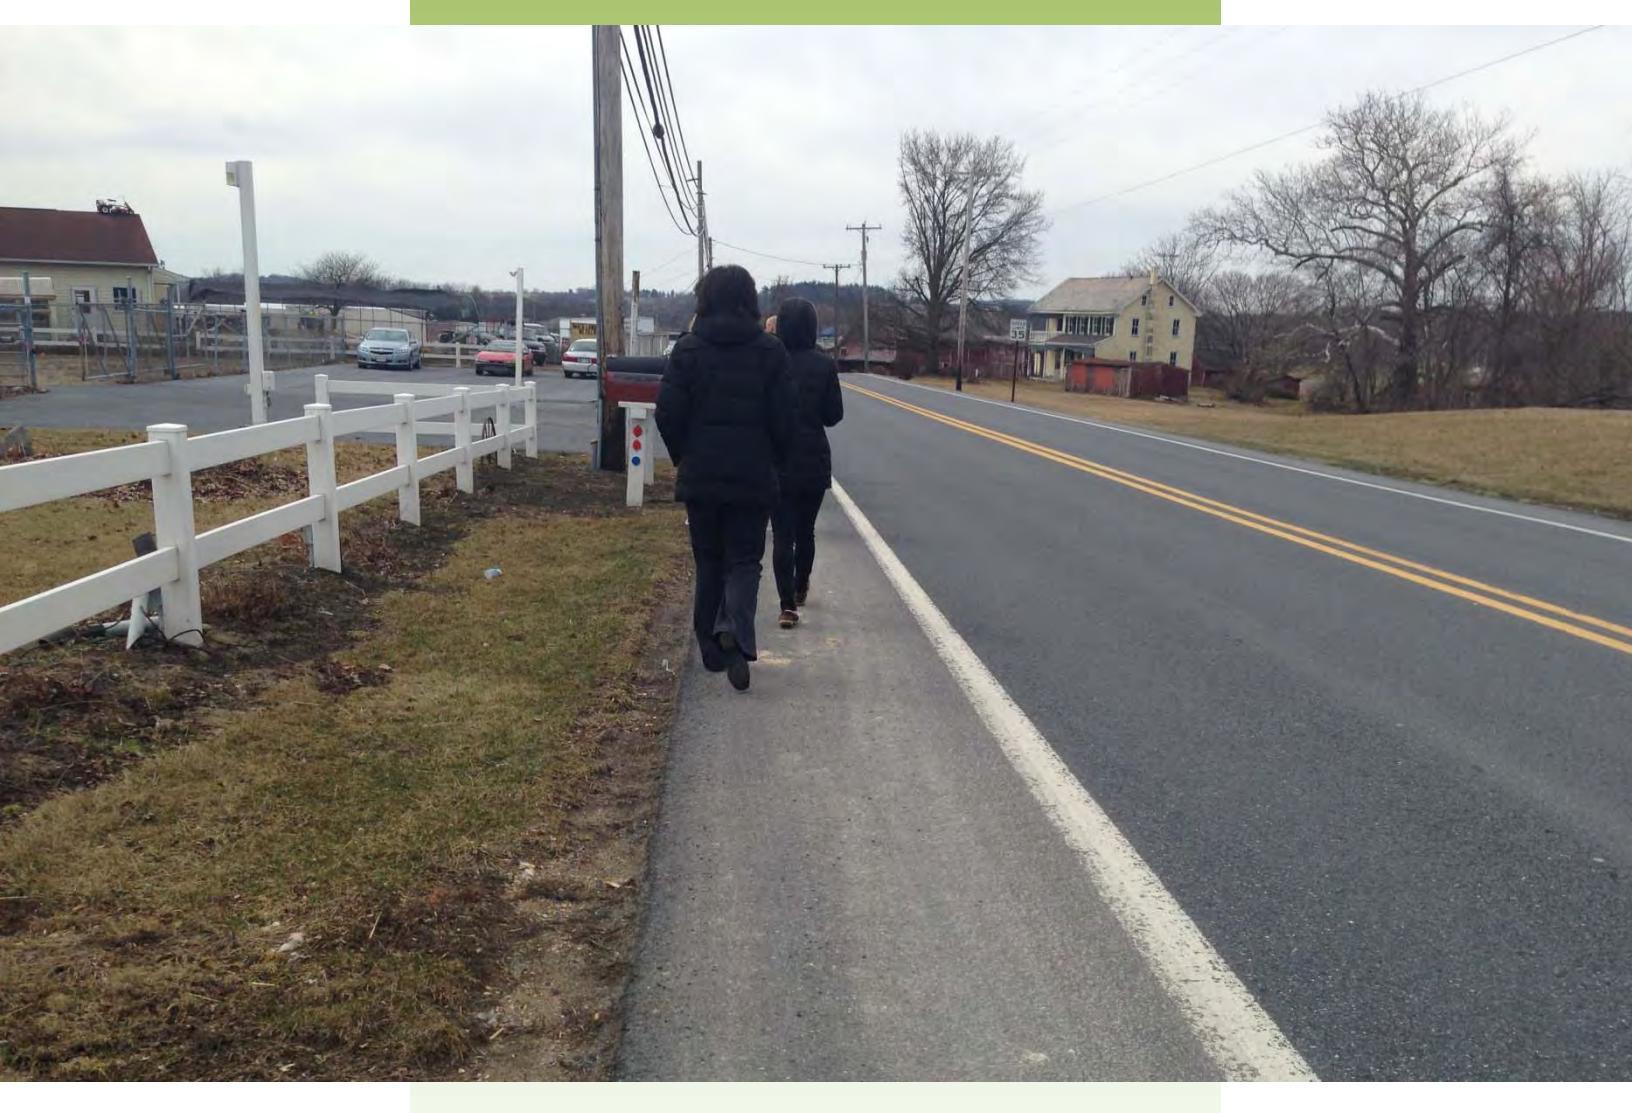
No sidewalks are provided along Doe Run Road. Pedestrians use the shoulder for travel

Walkability improvements to Doe Run Road would include adding curb and sidewalk to provide a dedicated pedestrian travel way. A grass strip (preferably 4-6 feet wide) can provide separation from heavy traffic. Street trees provide shade and a protective barrier from vehicles, as well as add to the visual appeal of the area.

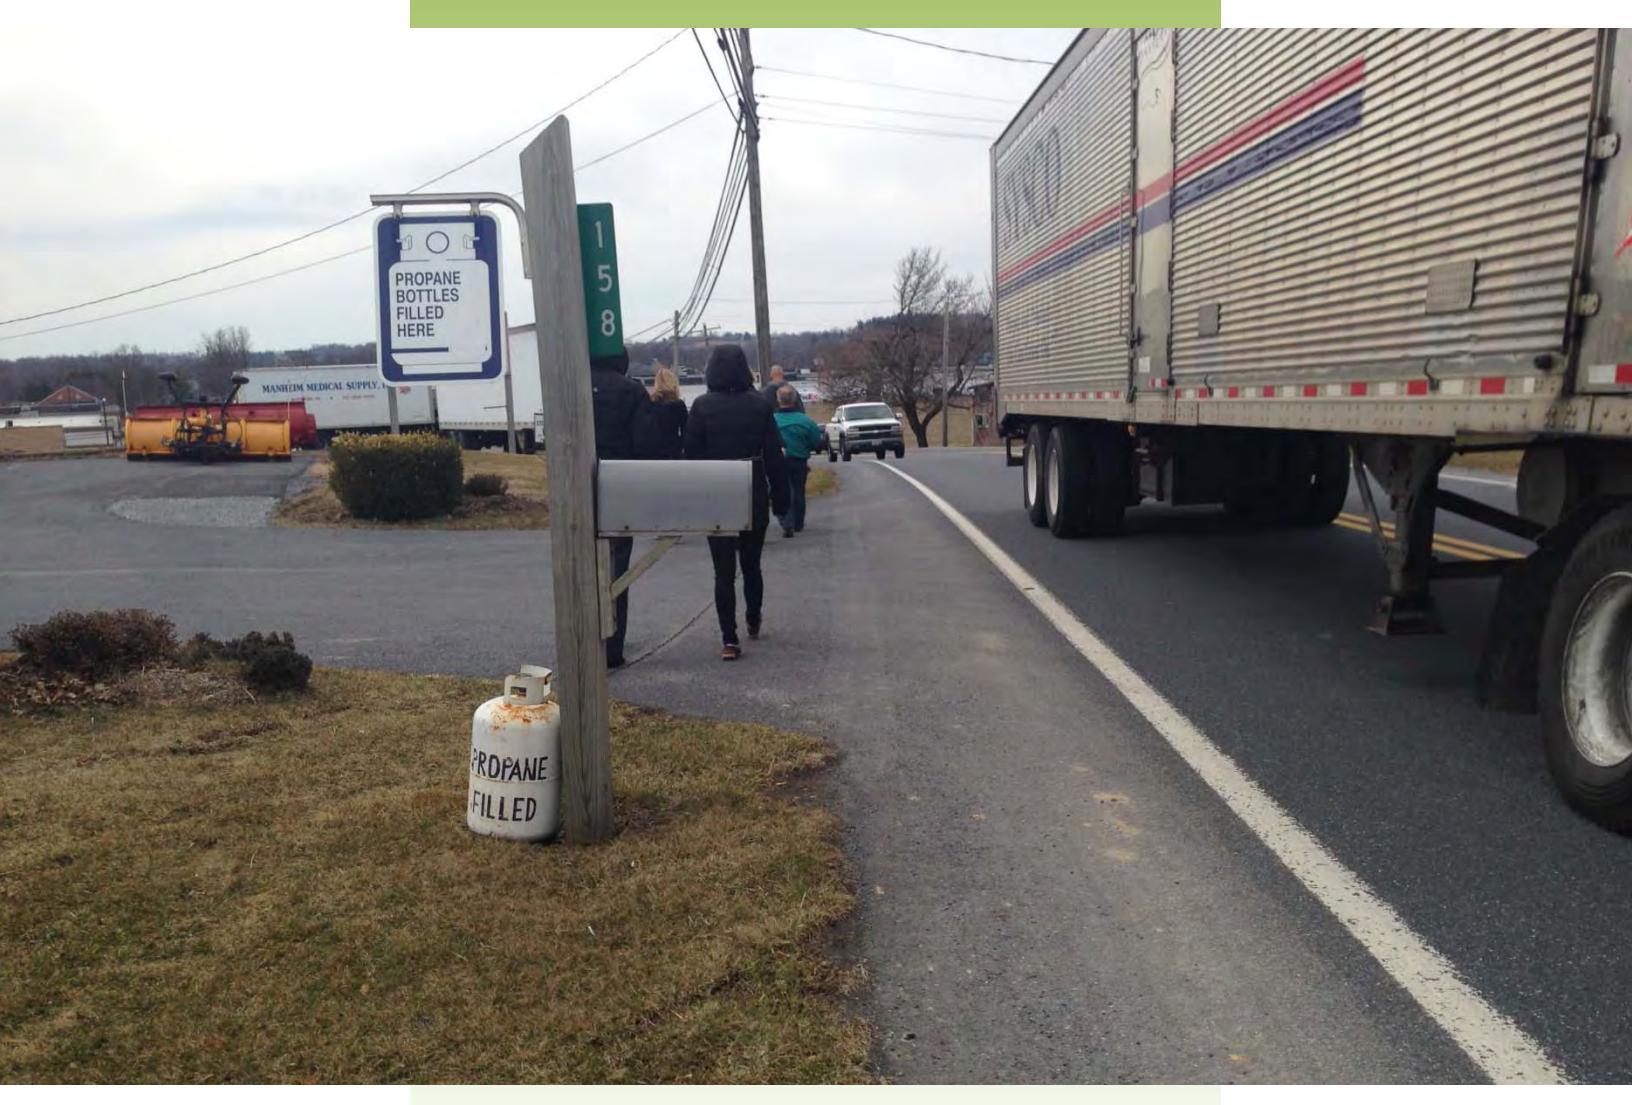
Heavy truck traffic on Doe Run Road makes walking uncomfortable and unsafe. Pedestrians seek safer walking conditions by walking in the grass instead of the shoulder.

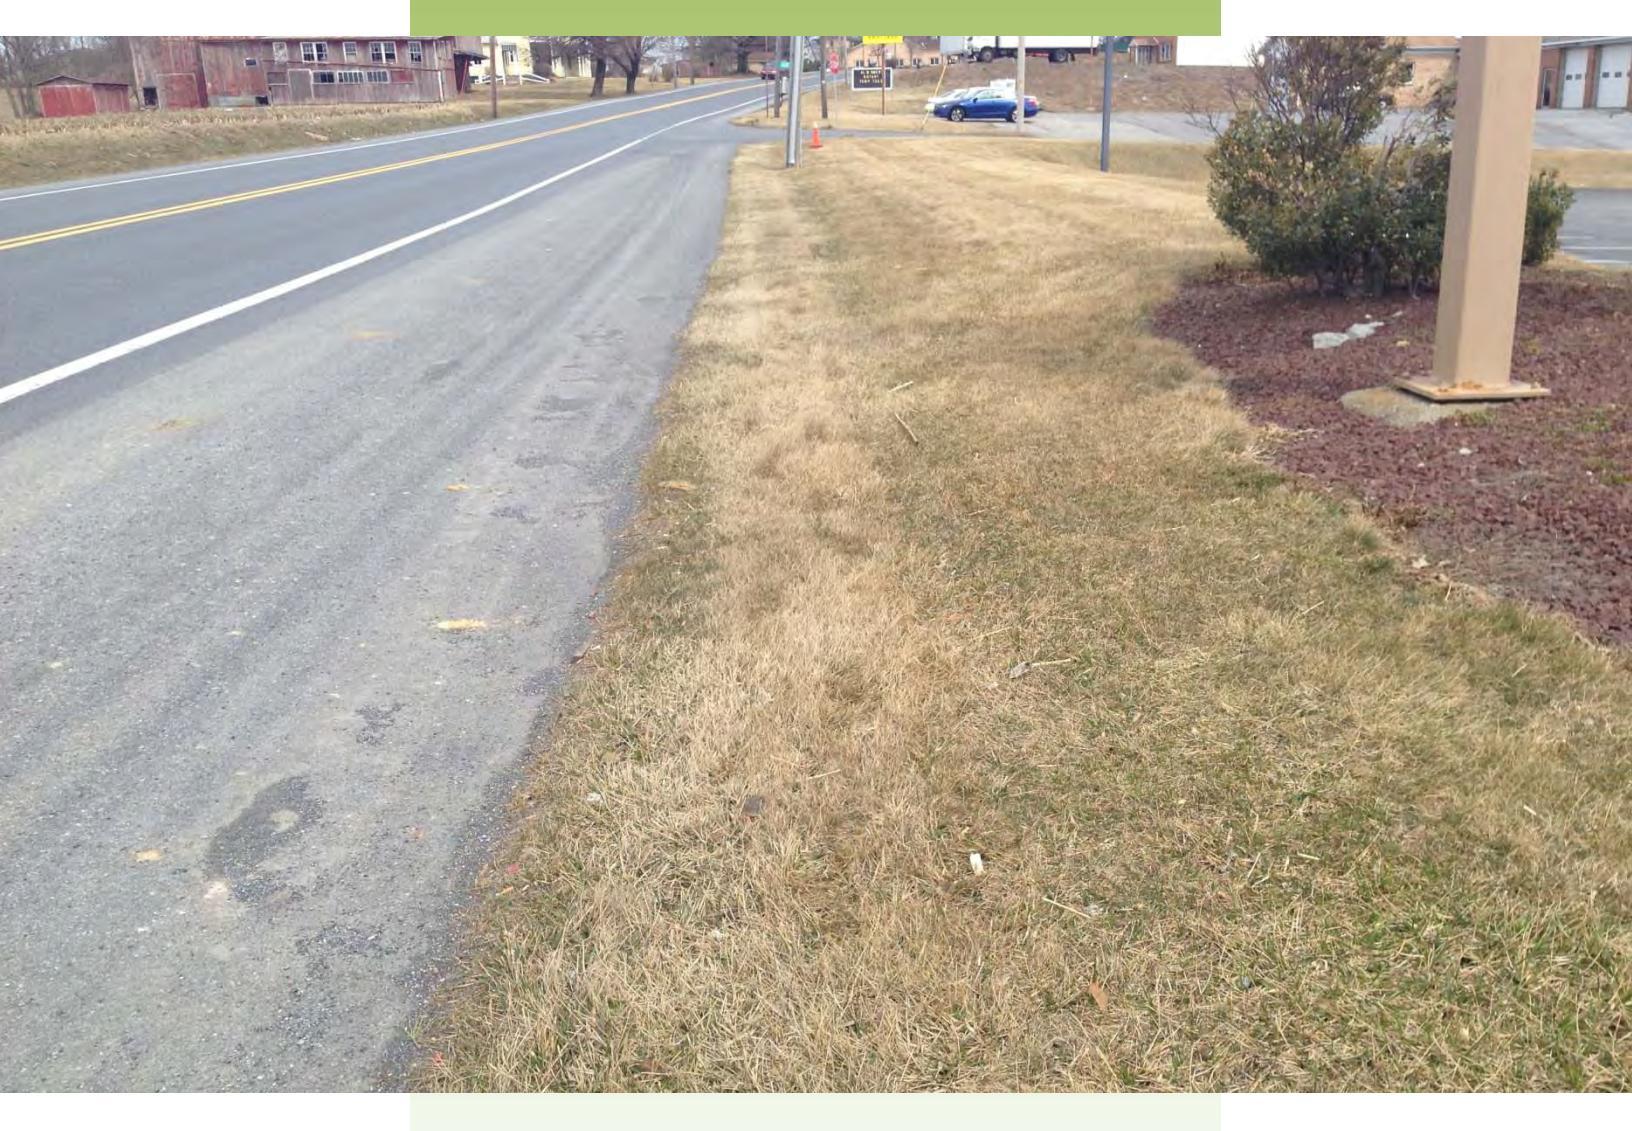
An informal trail through the grass along the shoulder is visible. This indicates that pedestrians currently use Doe Run Road for travel.

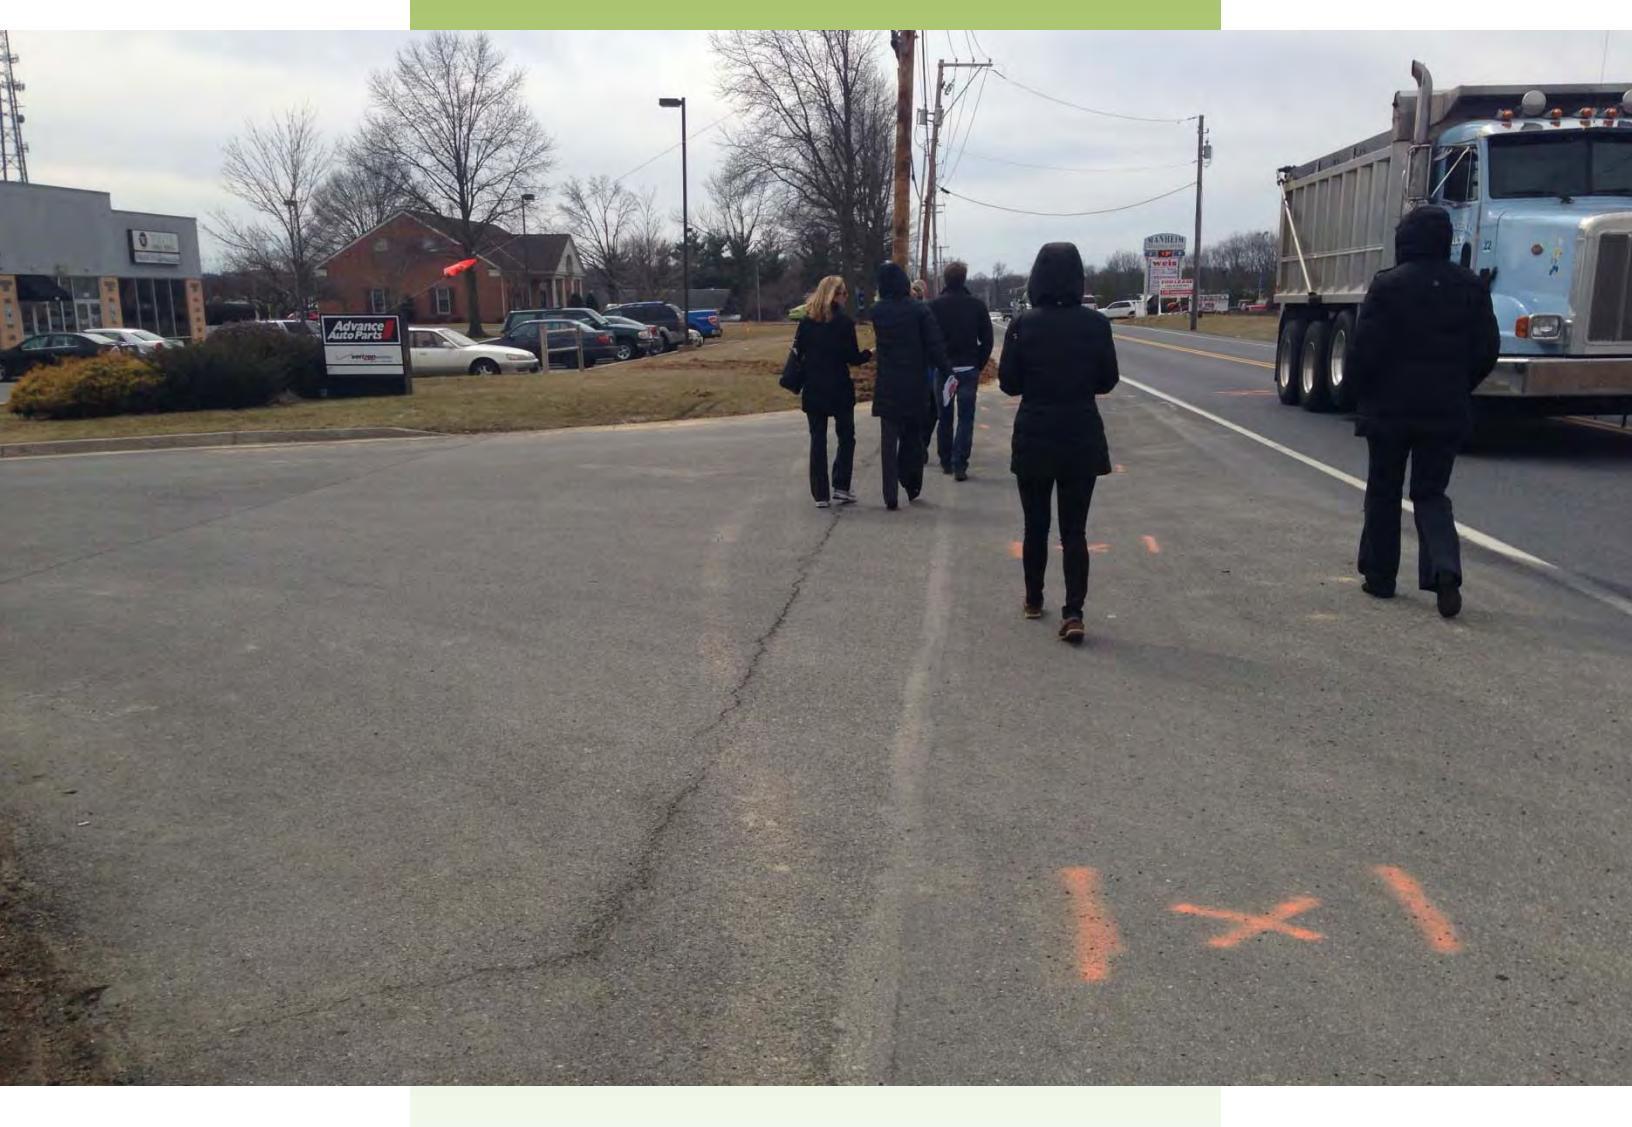
Wide driveway widths are undesirable for pedestrian traffic as they offer greater opportunity for conflicts with vehicles and do not protect walkers. Crosswalks might be appropriate for heavily used driveway.

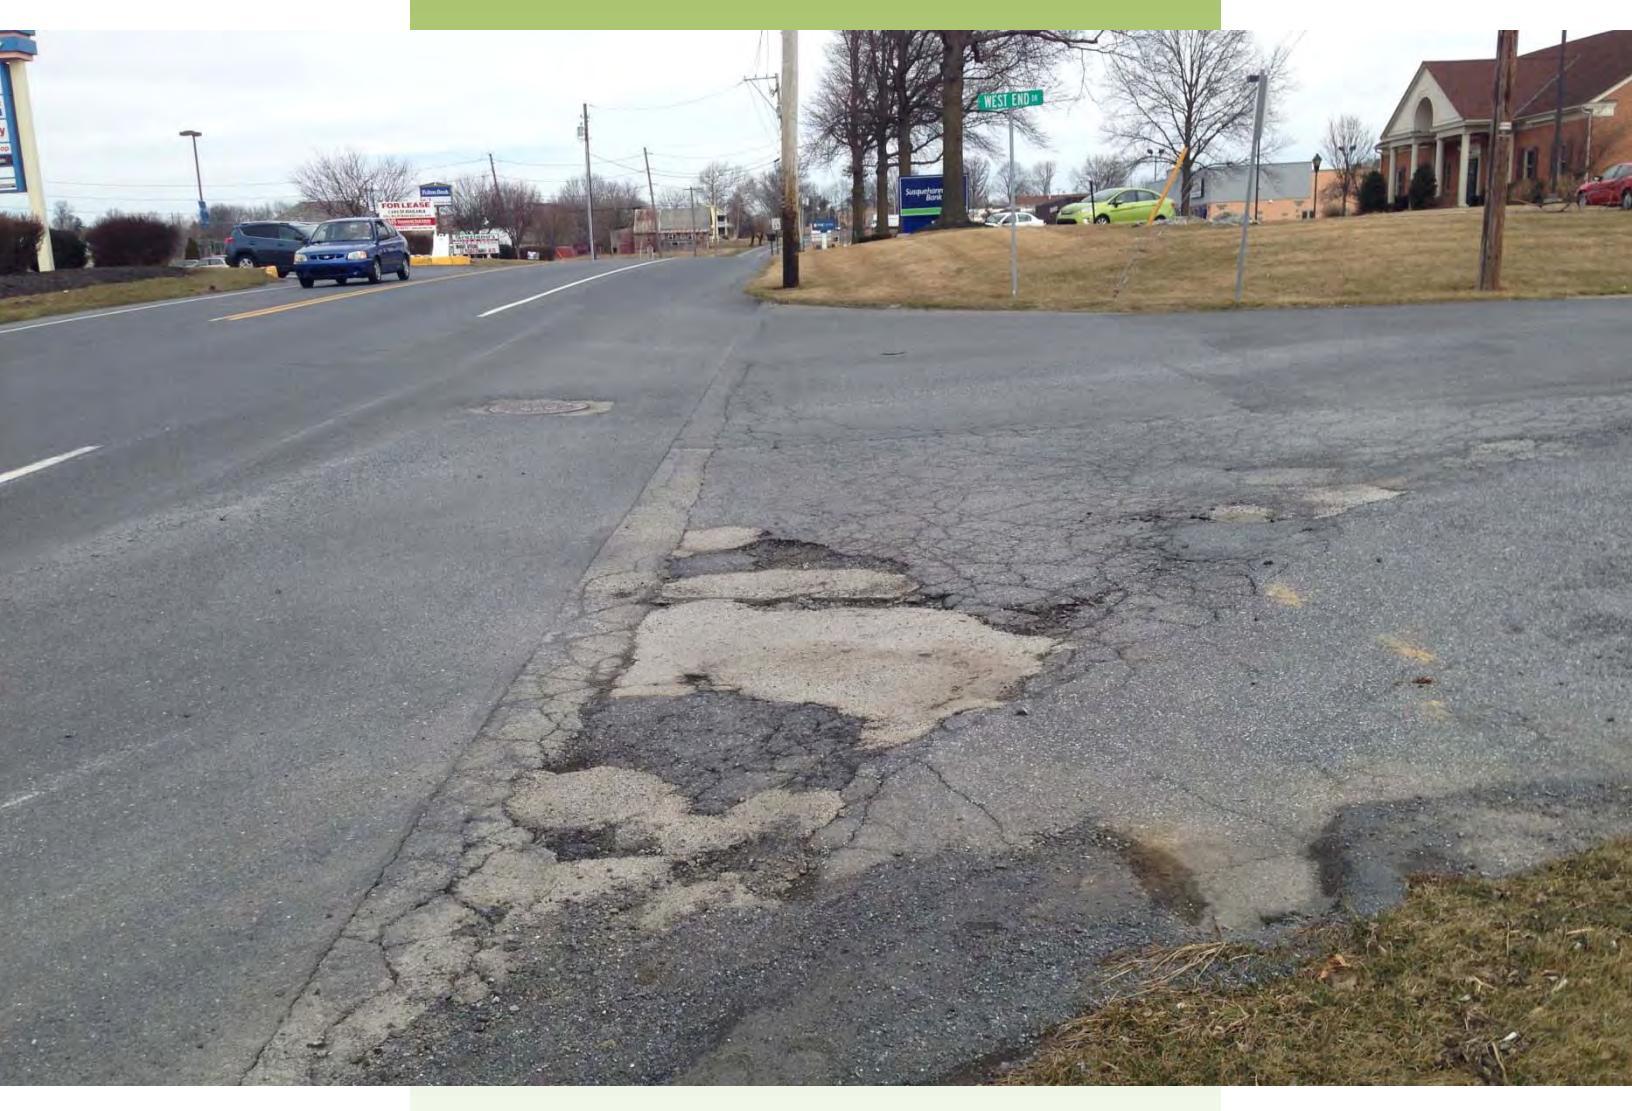
No ADA accessible curb ramps or crosswalks are provided at the intersection with West End Drive. Note that a pedestrian signal and associated improvements are planned for this intersection, including the realignment of the access drive for the Manheim Shopping Center (not shown) to be directly opposite West End Drive.

Provide sidewalks, pedestrian crosswalks, ADA ramps pedestrian signals and push buttons at all intersections.

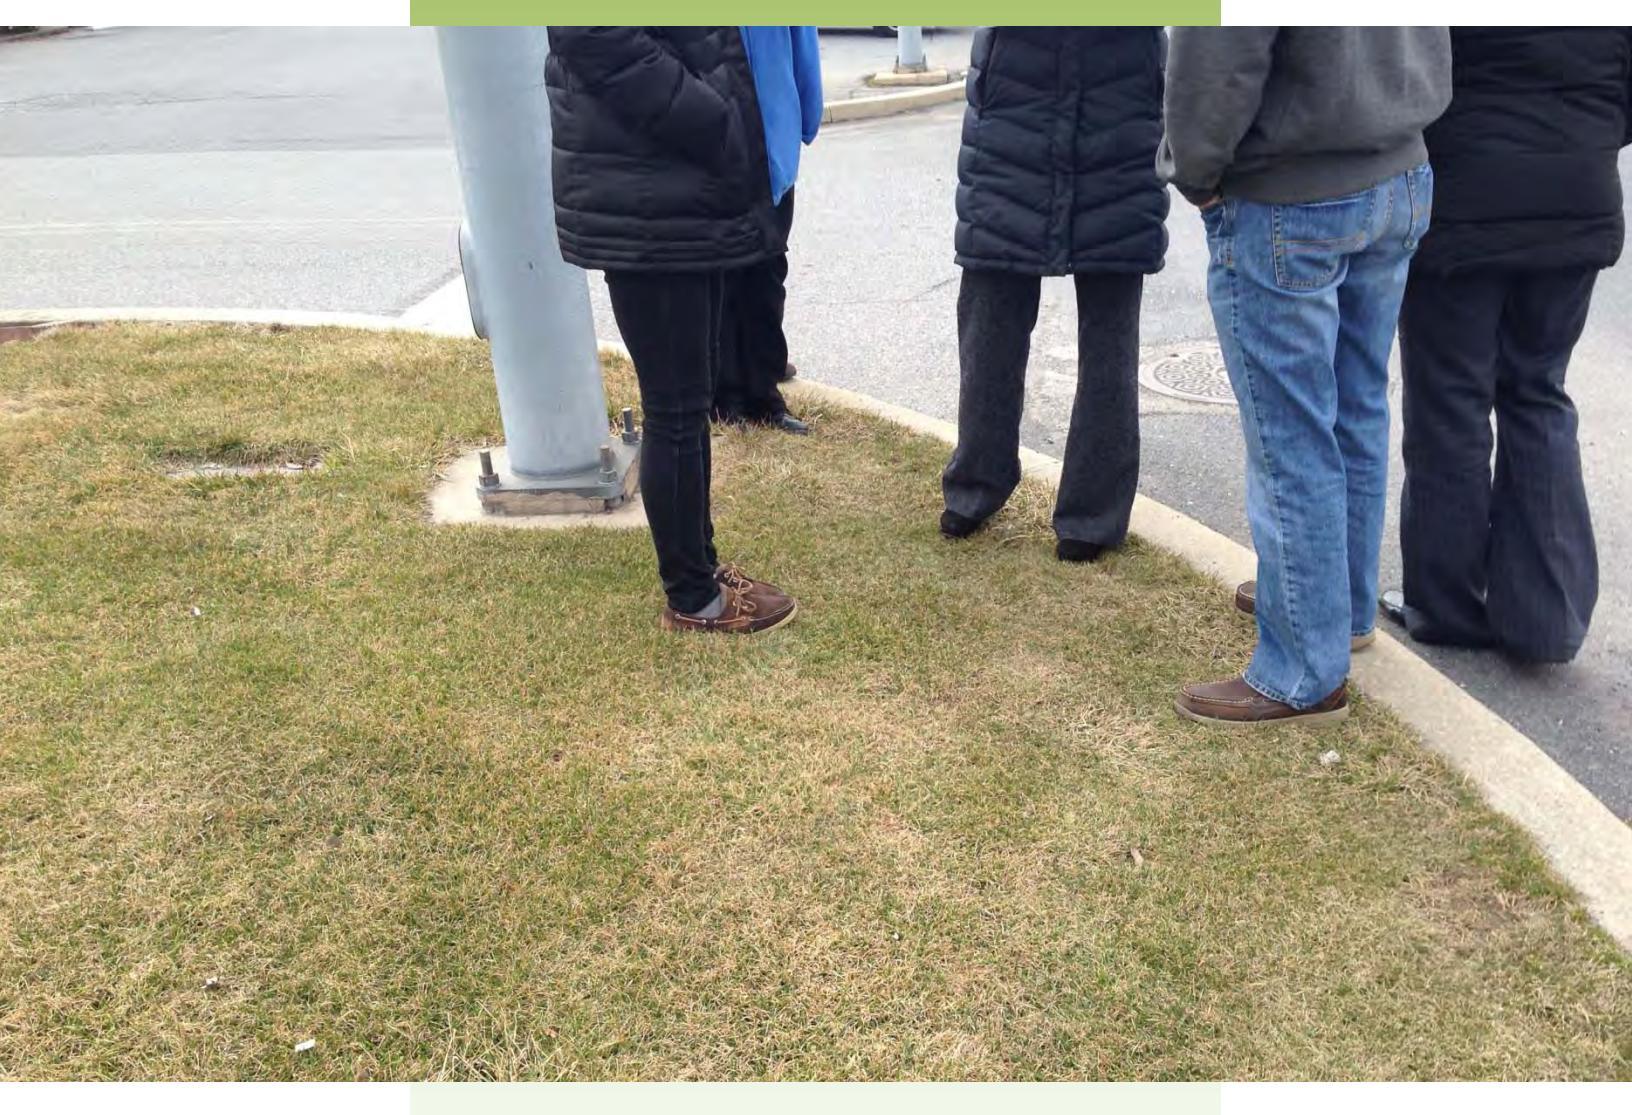
No ADA accessible curb ramps or crosswalks are provided at the intersection of Doe Run Road and White Oak Road.

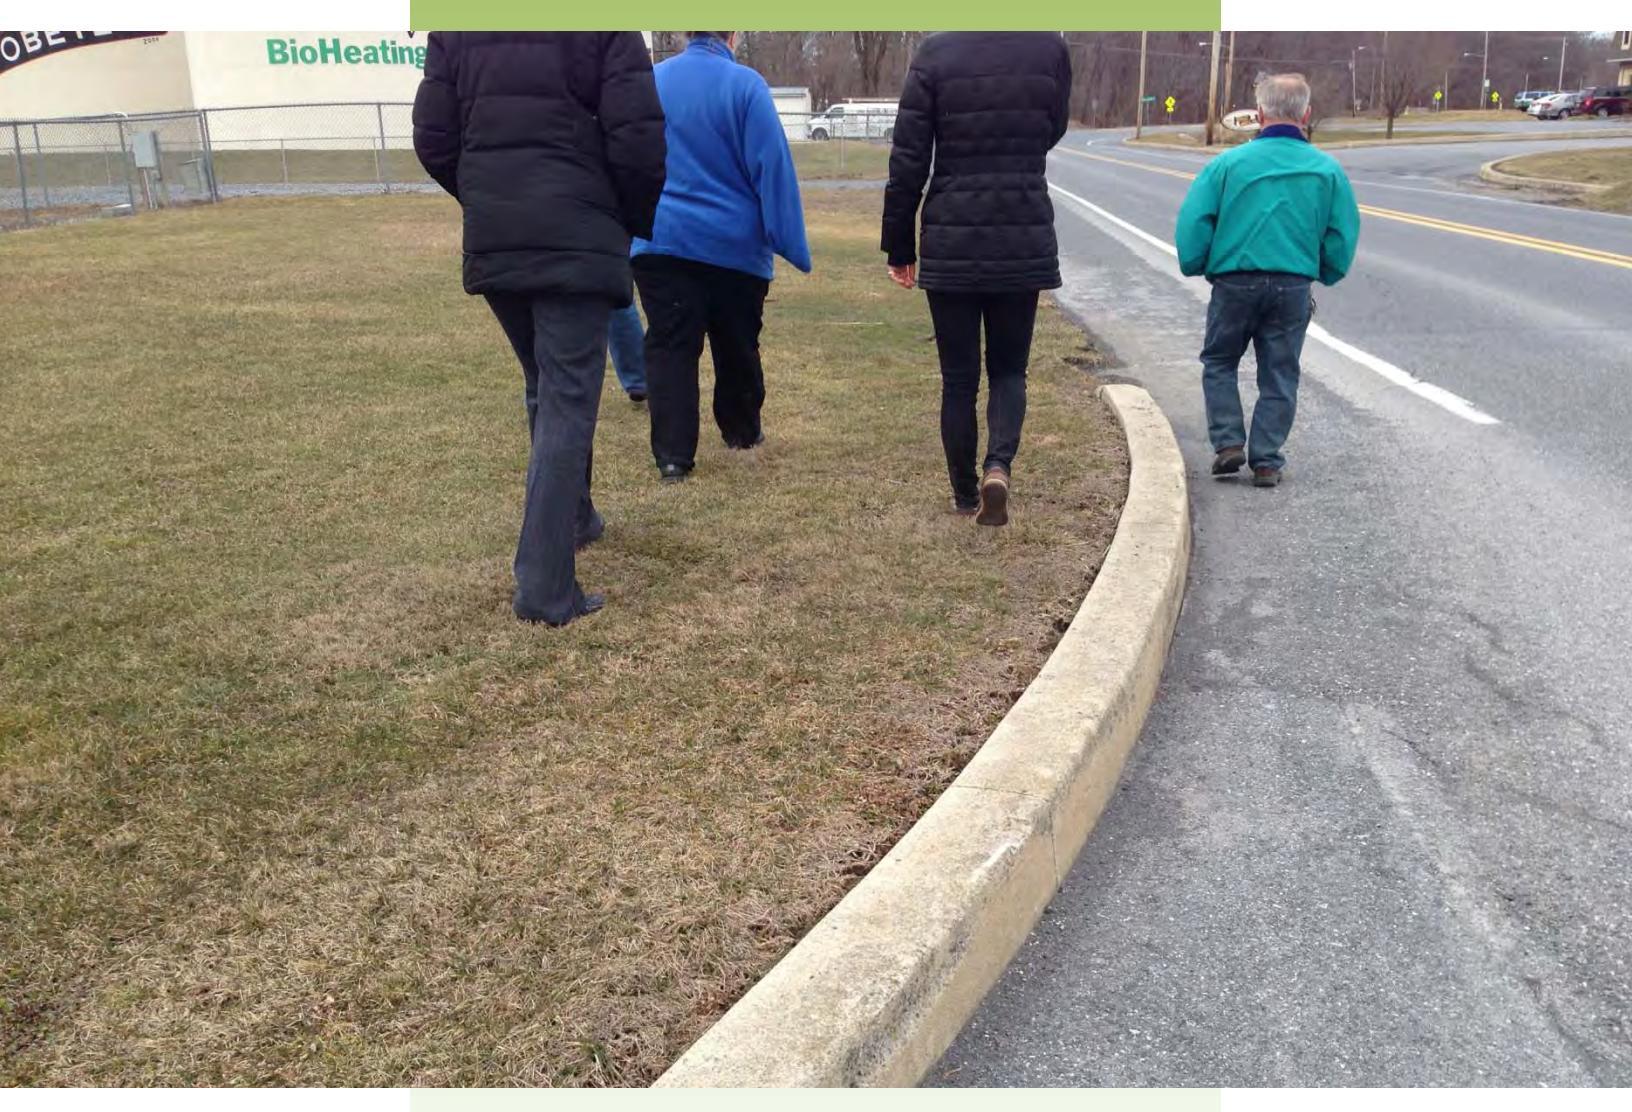
WHITE OAK CONDITIONS

No sidewalks are provided along White Oak Road.

There appears to be adequate space for the installation of curb and sidewalk along the west side of White Oak Road. This would provide a connection from the middle school area to the destinations along Doe Run Road. Alternate routes do exist from the dense residential areas within the Borough, therefore this segment of road is likely a lower priority based upon lower pedestrian demand.

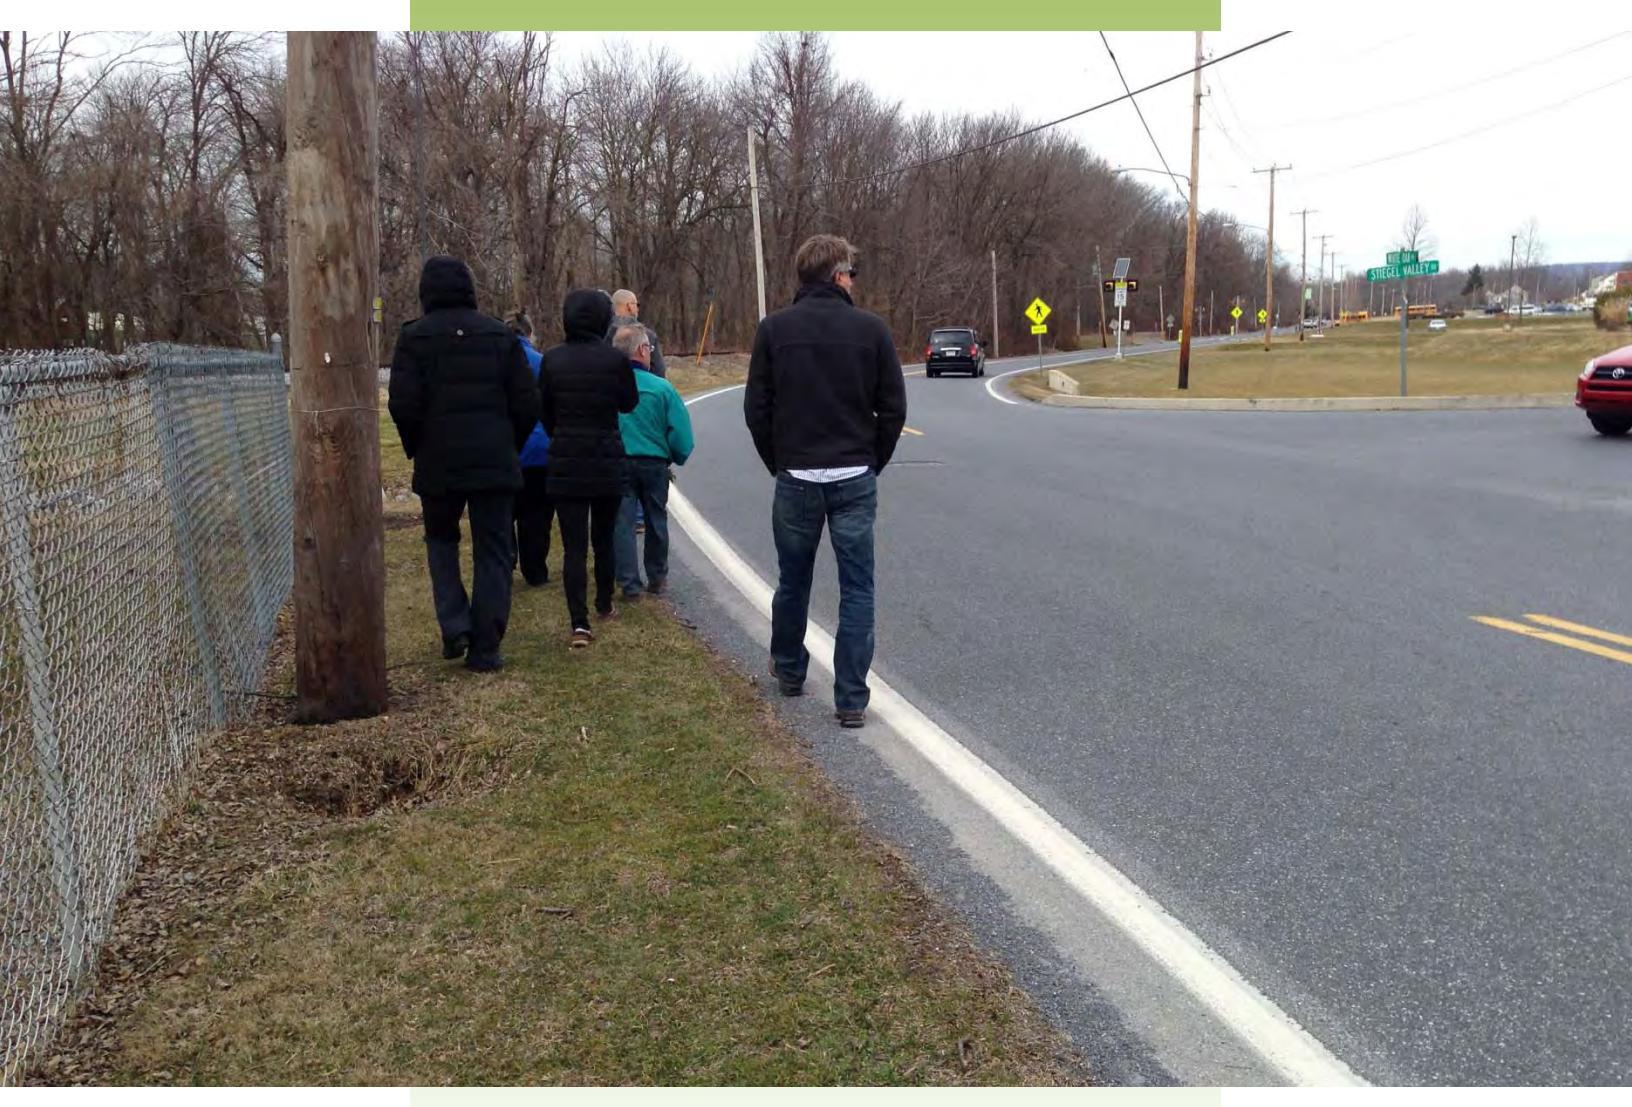
WHITE OAK CONDITIONS

No shoulders are provided. Pedestrians are forced to walk very close to traffic.
