WALKABILITY AUDIT REPORT PENN TOWNSHIP LANCASTER CO.

Reducing chronic disease among Lancaster County resident

WALK AUDIT BACKGROUND

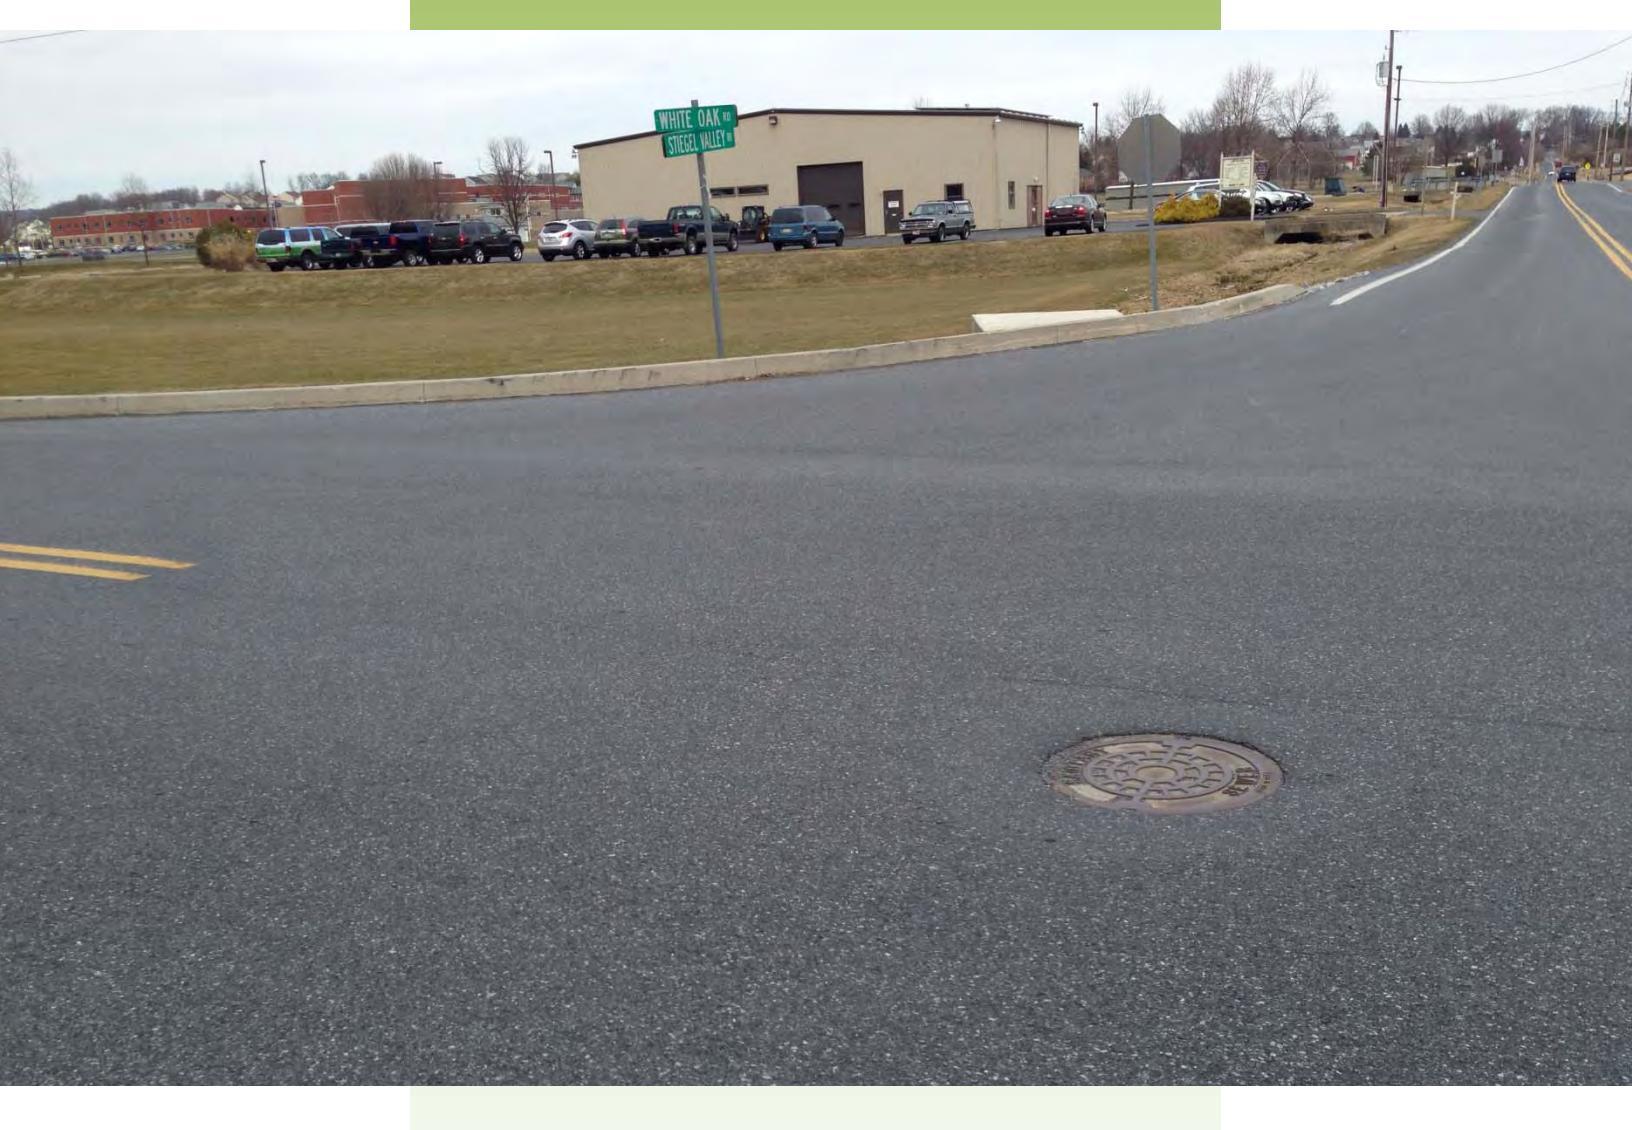
WHITE OAK CONDITIONS

No ADA accessible curb ramps or crosswalks are provided at the intersection of White Oak Road and Stiegel Valley Road.

Provide sidewalks, pedestrian crosswalks, ADA ramps pedestrian signals and push buttons at all intersections.

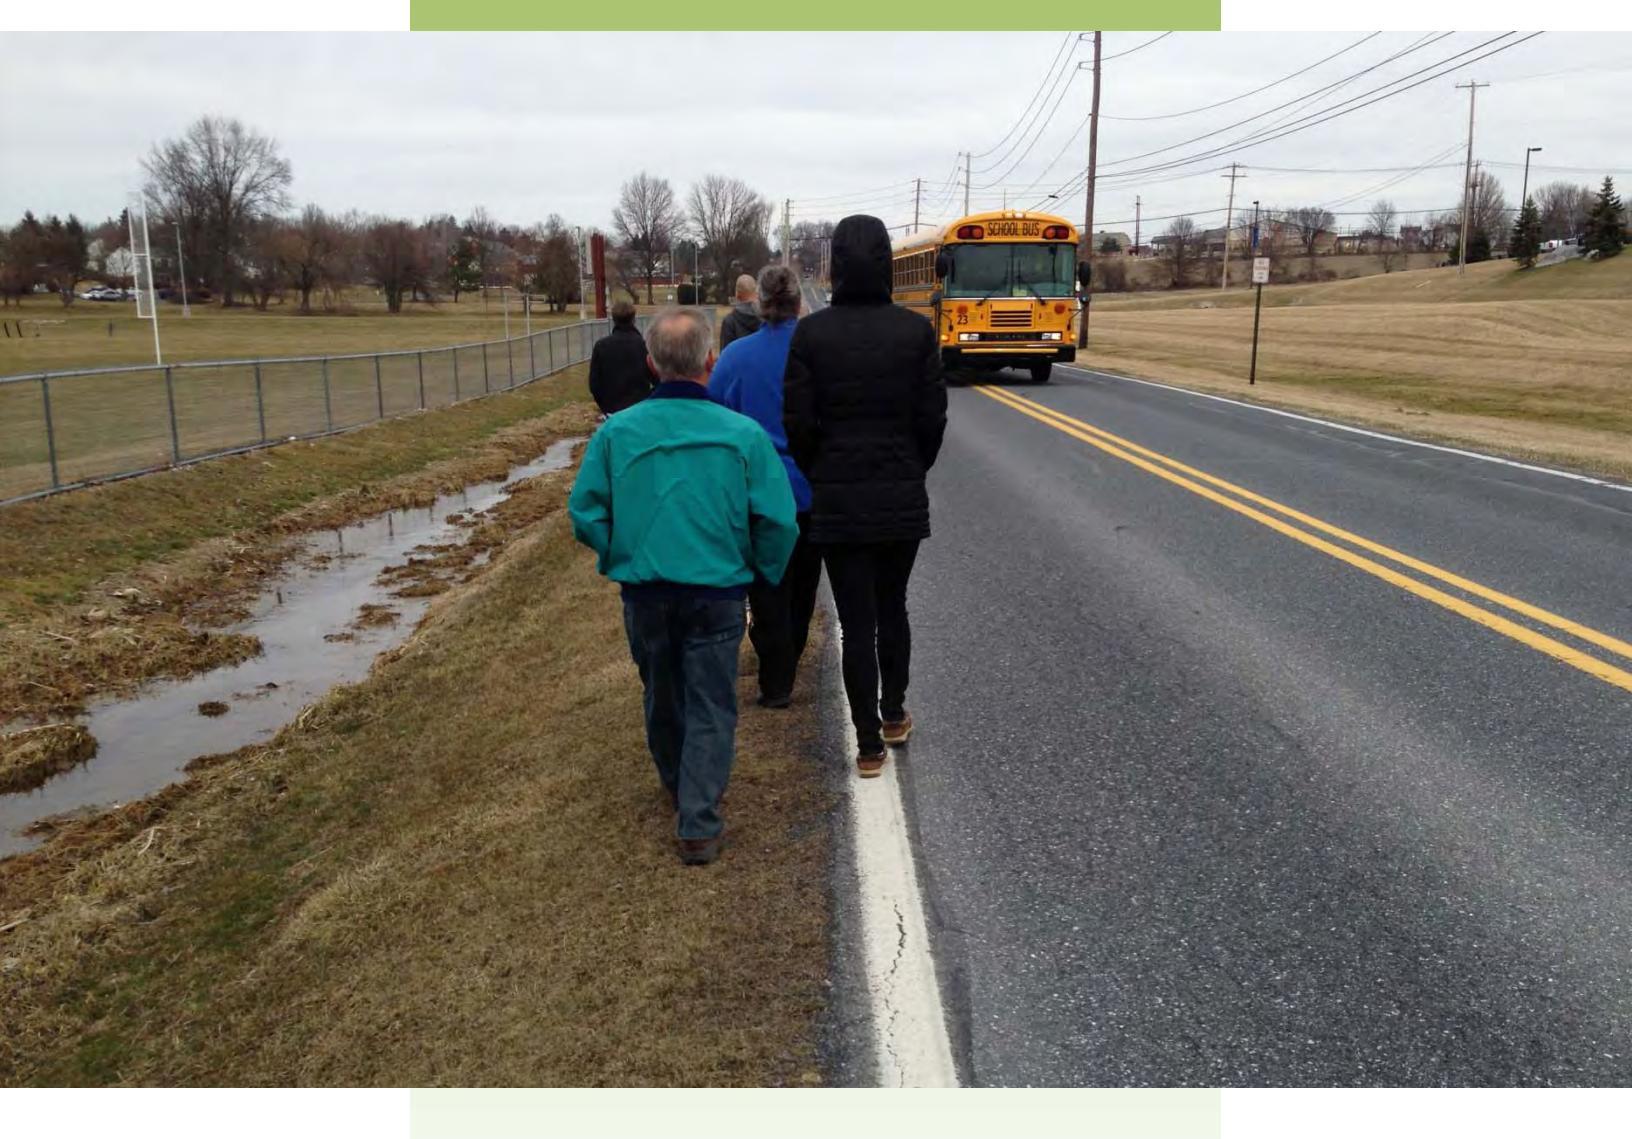
No sidewalks or shoulders are provided along the western portion of White Oak Road. A drainage swale along the north side of the road presents a challenge for the addition of future pedestrian walkways.

Options could be explored for the feasibility of installing sidewalks on Stiegel Valley Road between White Oak Road and the middle school driveway. The existing drainage swale limits options to the north, however it may be feasible to provide a walkway to the south of the roadway in this area. Due to the availability of the middle school walkways as a shortcut from the north and limited demand for a sidewalk from the south, improving walkability for this portion of Stiegel Valley Road is a lower priority item than the Doe Run streetscape and/or intersection improvements.

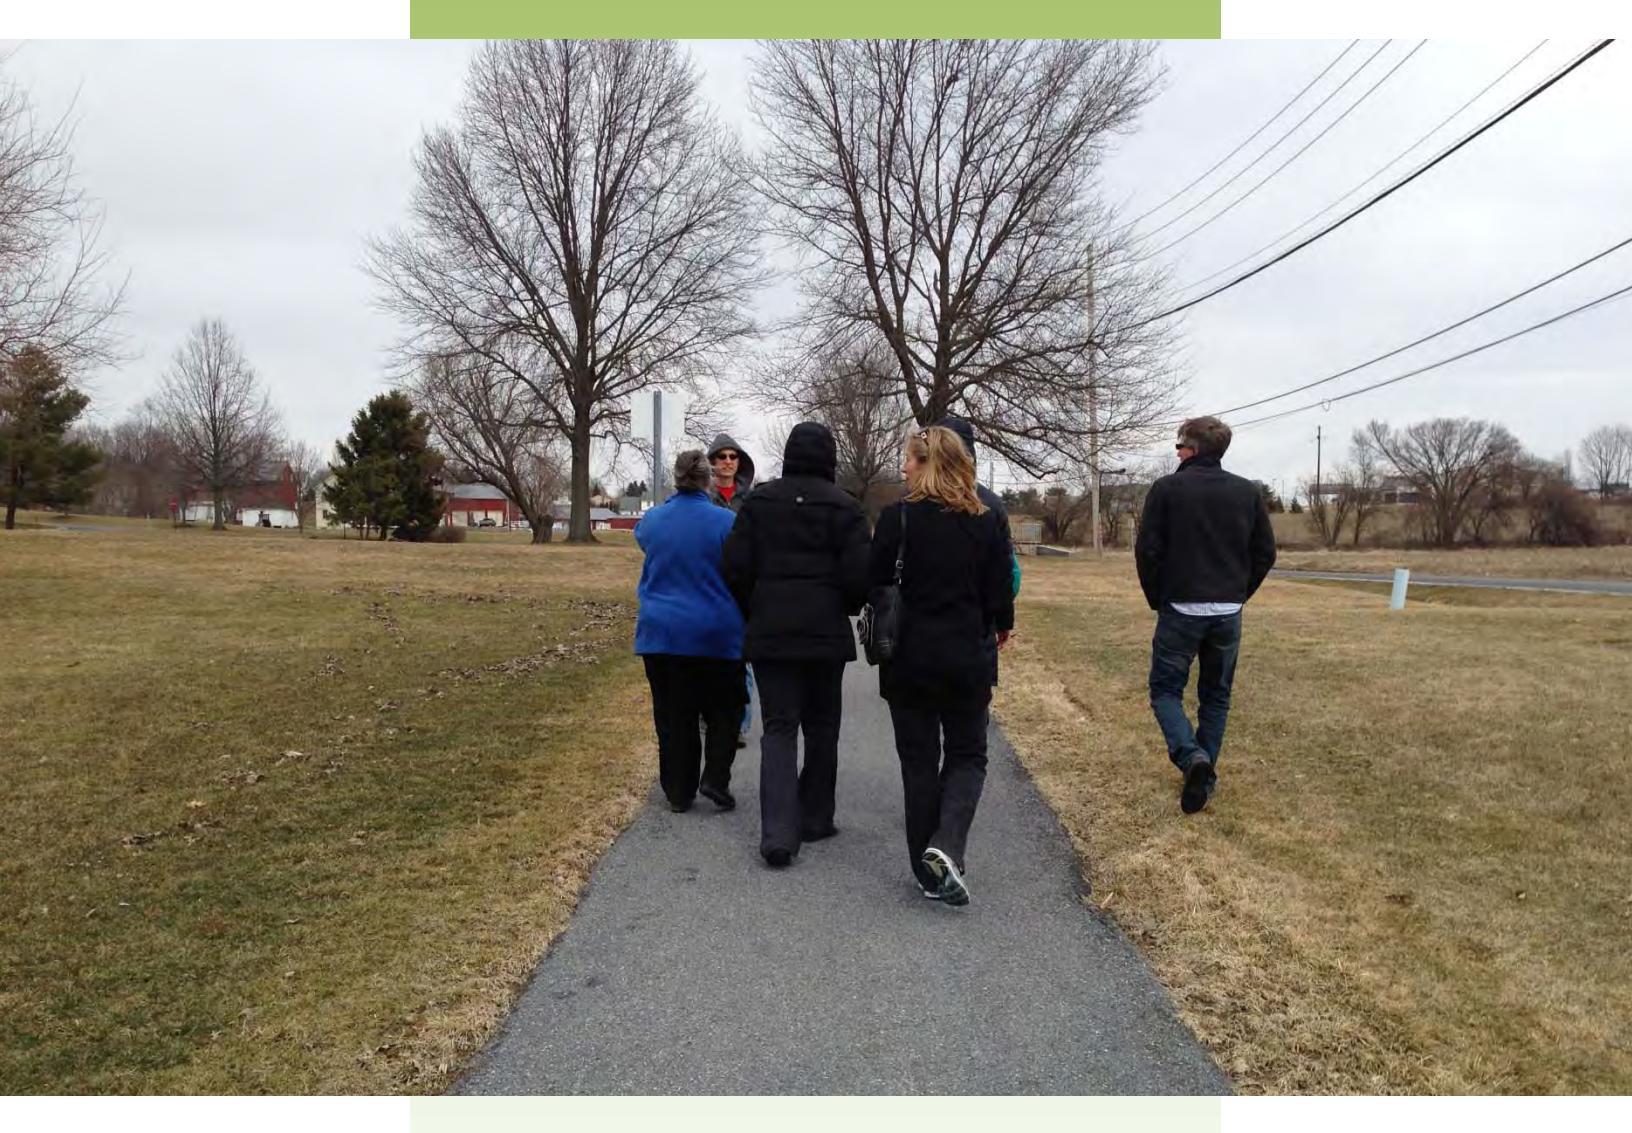
Starting at the driveway for the Manheim Central Middle School a walking path is provided along the north side of the road.

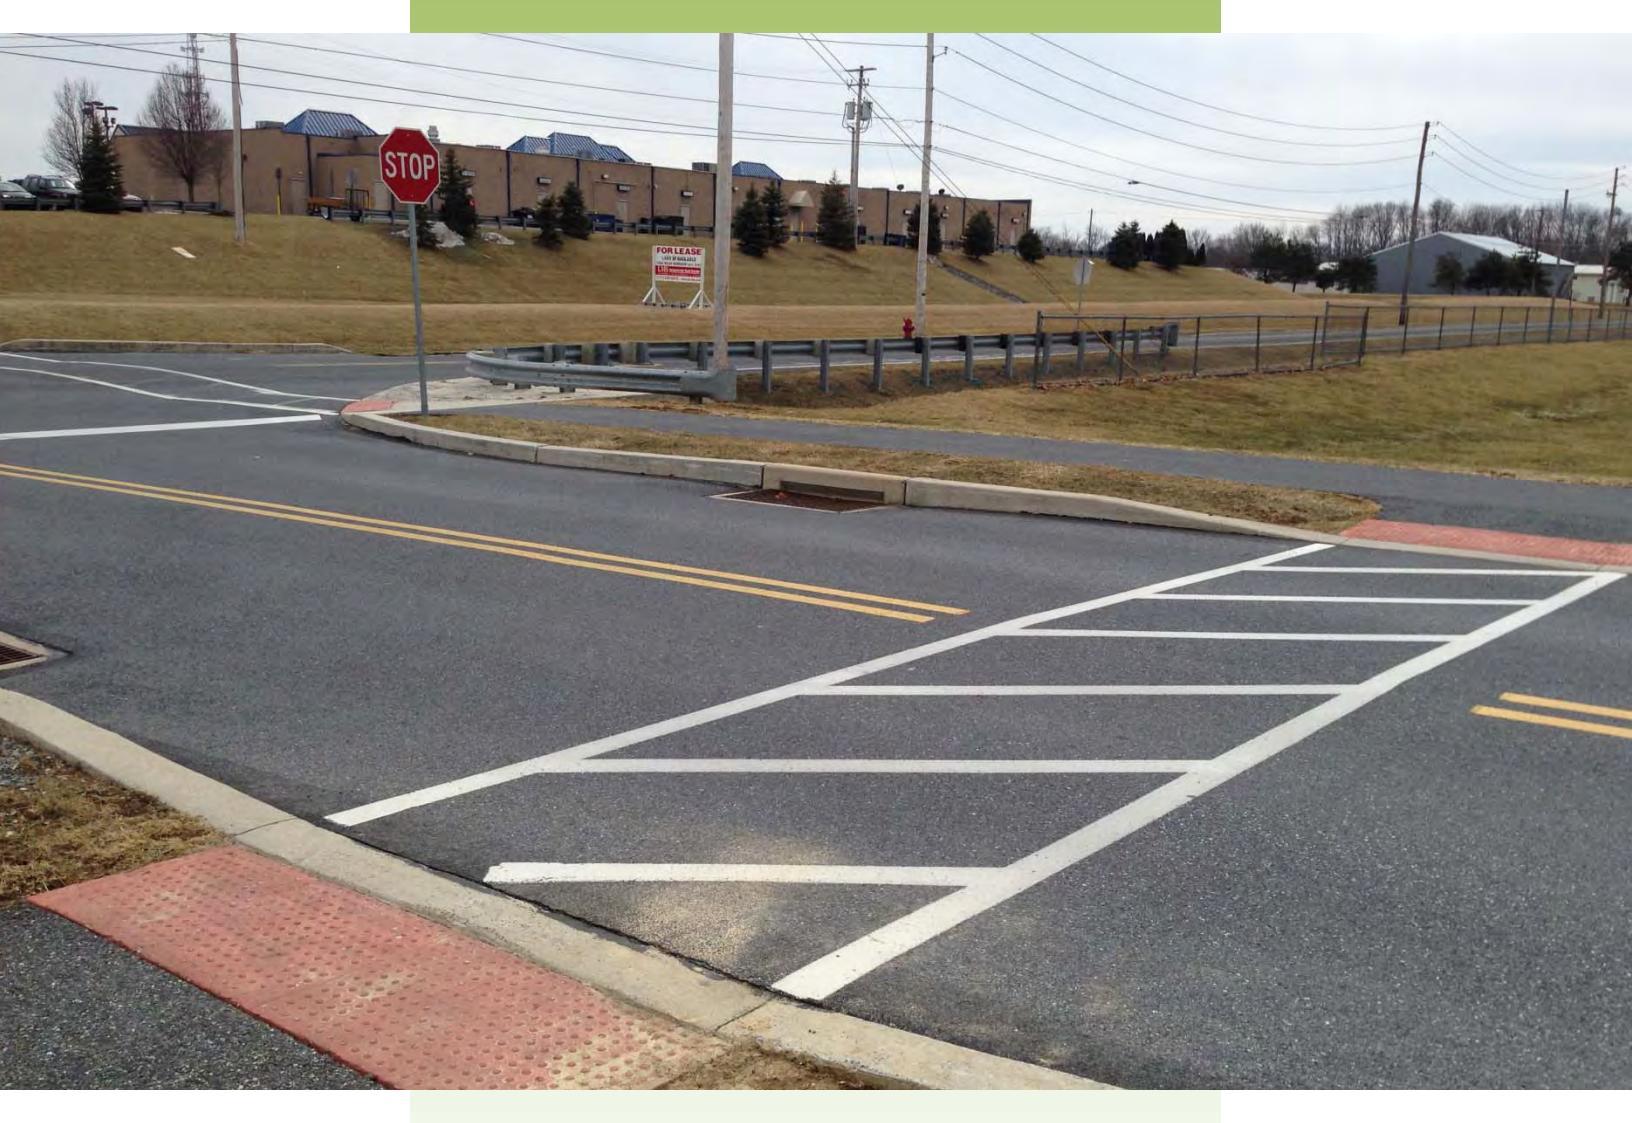
Pedestrian crosswalks and ADA ramps are typically provided along Stiegel Valley Road

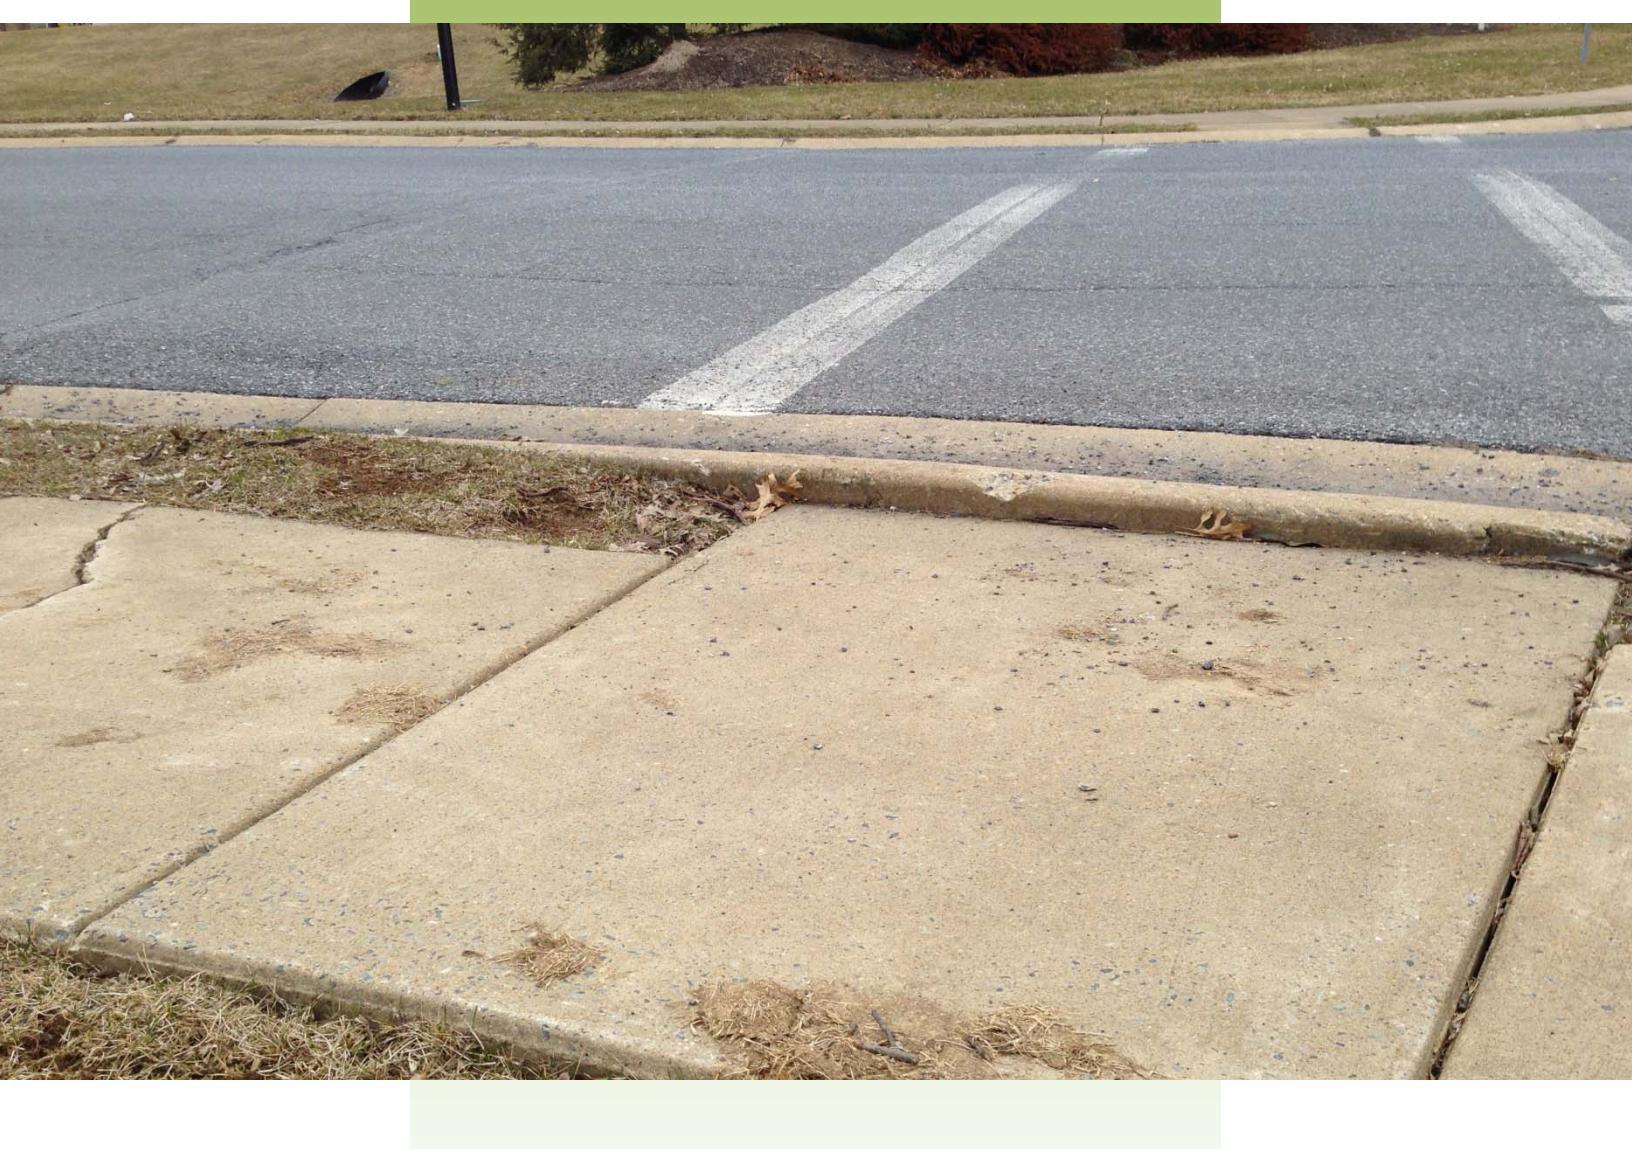
Some ramps do not meet current ADA standards. No warning mat is provided and there is a vertical separation of several inches between the sidewalk and the rolled curb.

Retrofitting existing curb ramps to meet current ADA standards would increase walkability for disabled residents. Improvements could include adding truncated dome warning mats as well as eliminating vertical drops from settled curb and rolled curbing.

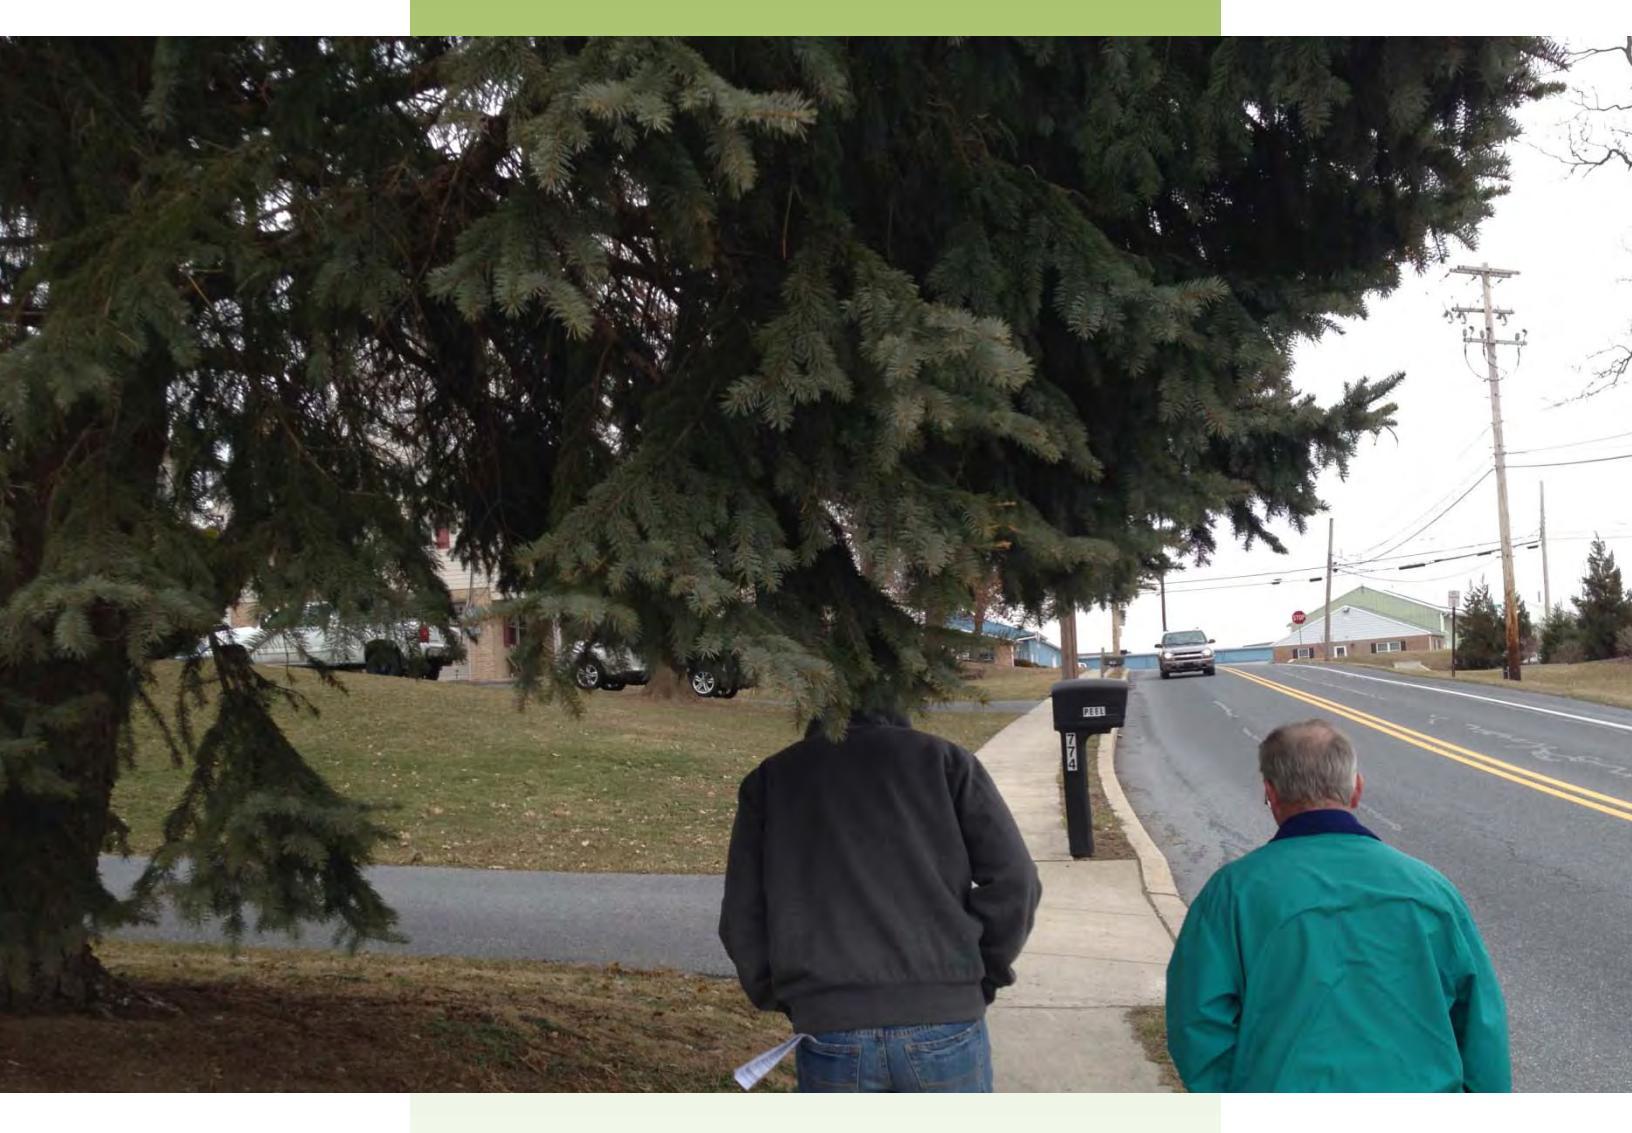
Several low hanging tree limbs need trimmed.

Trimming low hanging branches from trees would be a simple and effective way to improve walkability along Stiegel Valley Road.

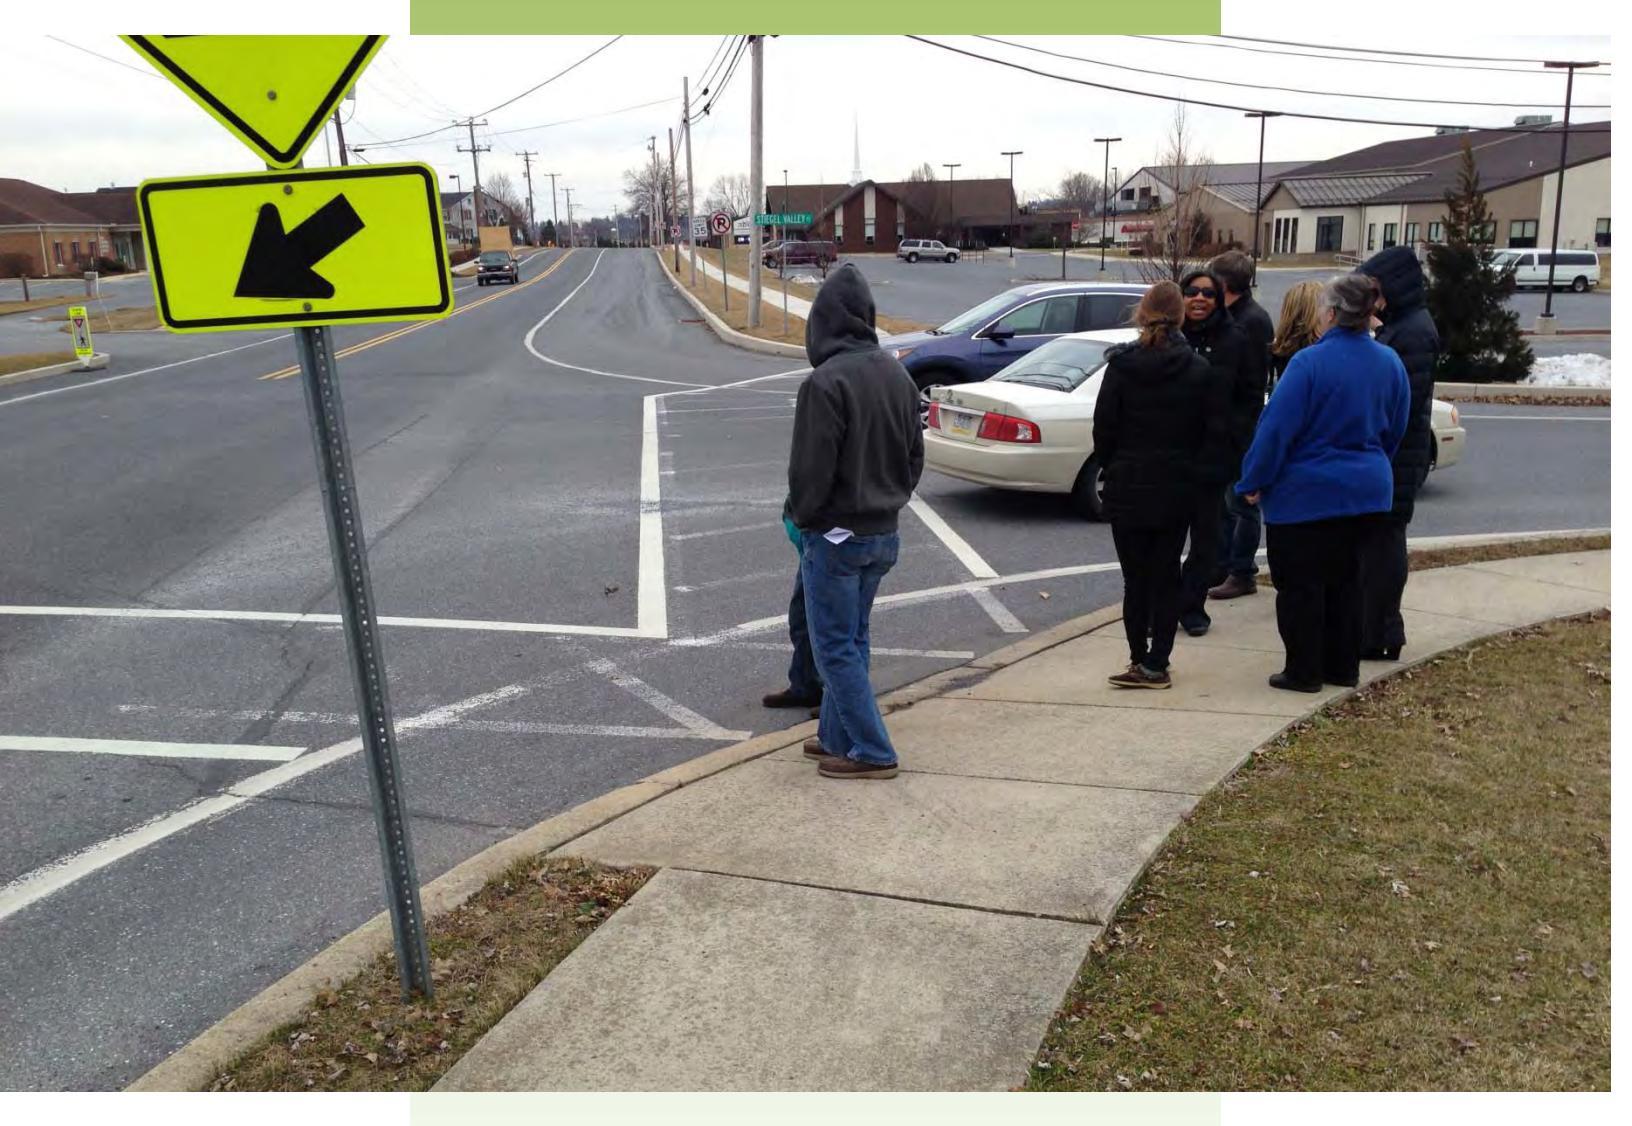
Pedestrian crosswalks and signage are provided at the intersection of Stiegel Valley Road and North Pennryn Road.

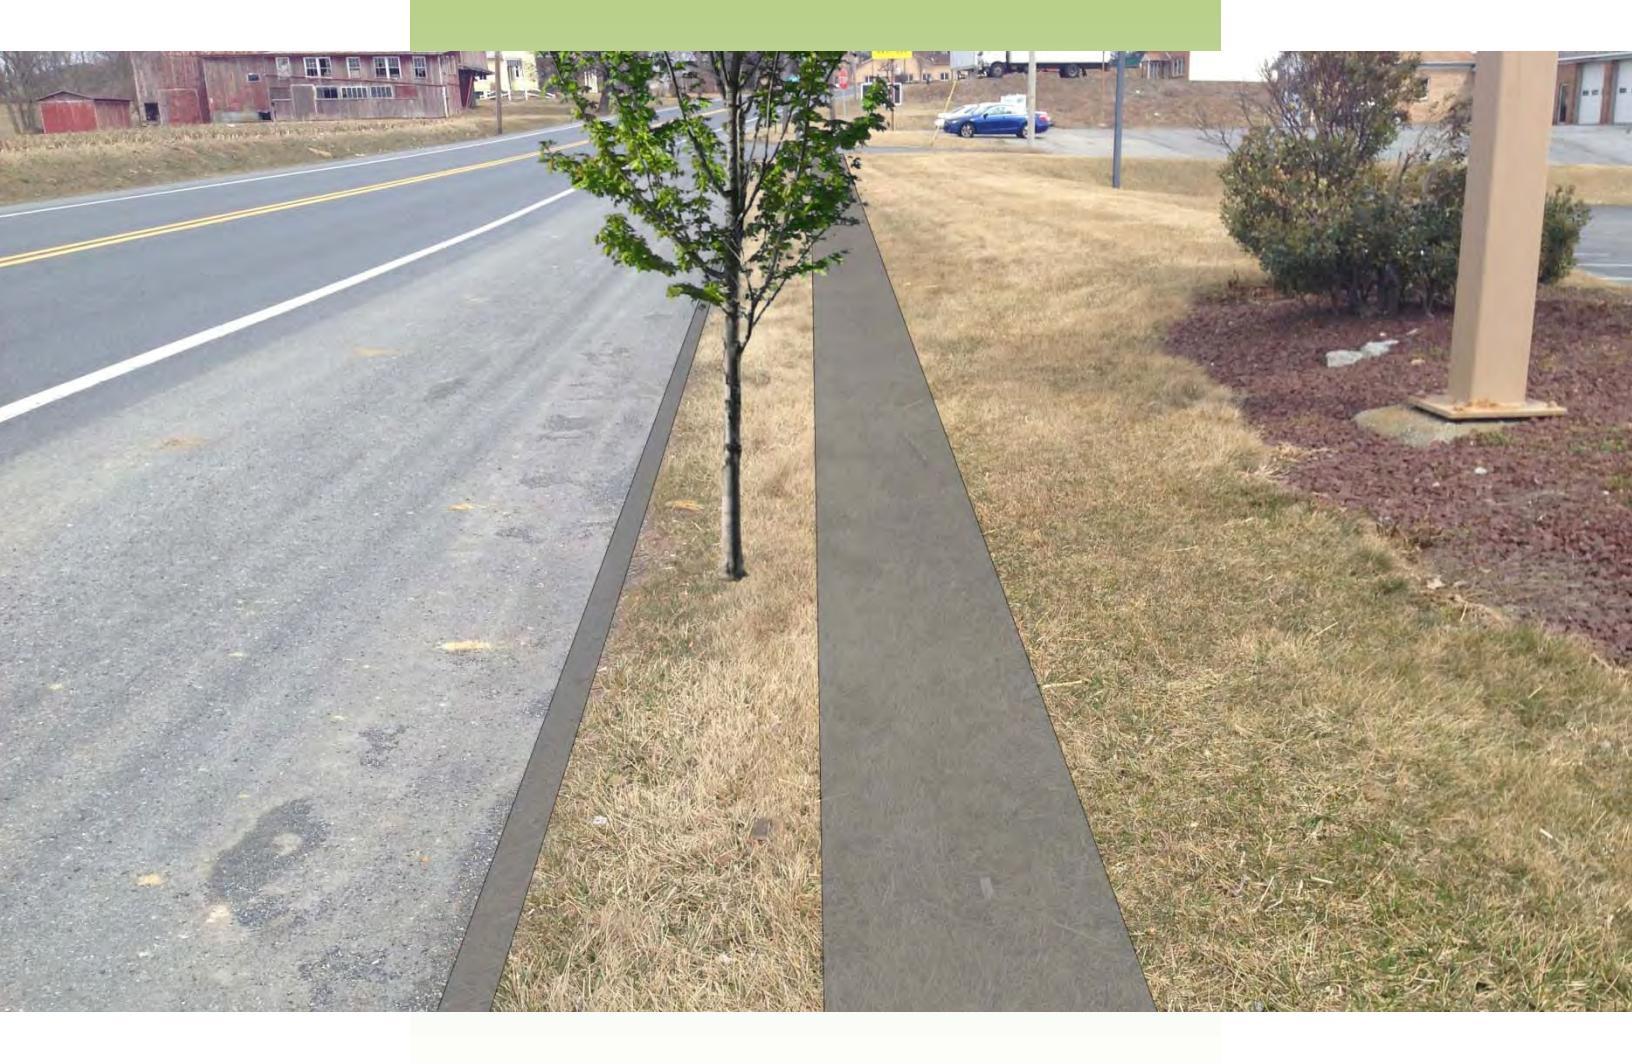
DOE RUN STREETSCAPE

Walkability improvements to Doe Run Road would include adding curb and sidewalk to provide a dedicated pedestrian travel way. A grass strip (preferably 4-6 feet wide) can provide separation from heavy traffic. Street trees provide shade and a protective barrier from vehicles, as well as add to the visual appeal of the area.

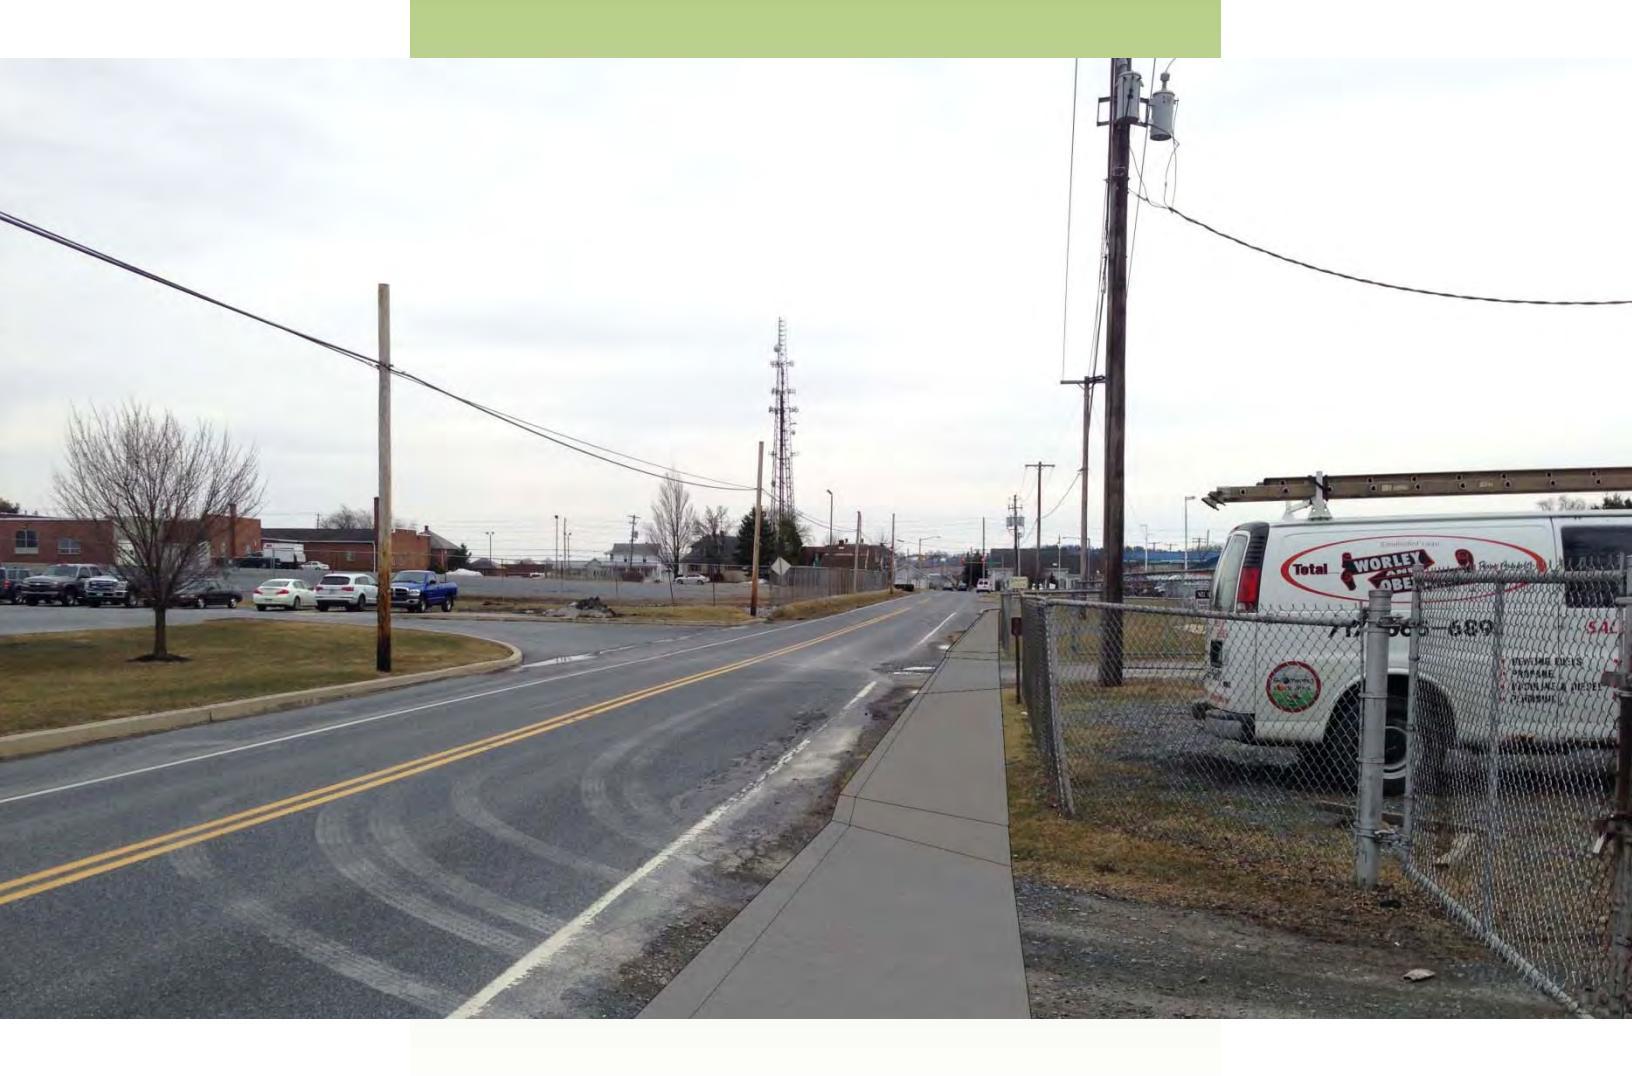
WHITE OAK CURB AND SIDEWALK

There appears to be adequate space for the installation of curb and sidewalk along the west side of White Oak Road. This would provide a connection from the middle school area to the destinations along Doe Run Road. Alternate routes do exist from the dense residential areas within the Borough, therefore this segment of road is likely a lower priority based upon lower pedestrian demand.
